Research on bearing behavior of the column composed of double limbs subjected to bending and compression in precipitator casing

Abstract. Cross-section of the column in enclosure structure of electrostatic precipitator casing is composed of double H-shaped limbs because of the requirement of supporting the top beam with a wide box section and bearing large axial compression. For the failure modes and failure mechanism of the composite section column subjected to the combined loads of axial compression and bending, nonlinear finite element method was used to study the bearing behavior of the column in consideration of the initial imperfection. Besides, the influence of eccentricity ratio was investigated. The results indicate that there were three possible failure modes of the column. The first was the elasto-plastic flexural-torsional buckling occurring on the front flange closely below the top. The second was the elasto-plastic flexural-torsional buckling occurring on the front flange at the mid-span of the top column segment. The third was the strength failure occurring on the web at the first braced location where the stresses reached yielding because of significant not only co

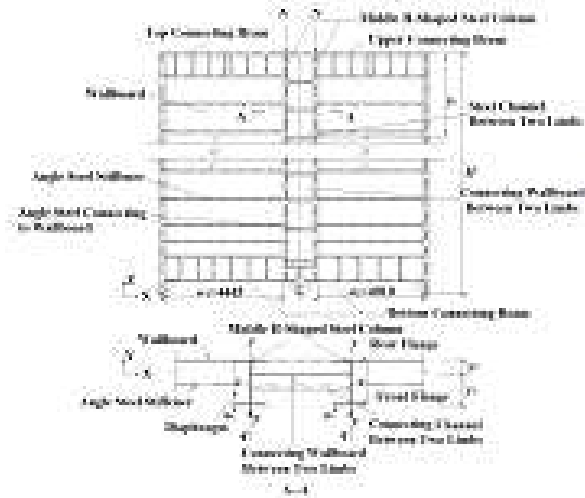
Fig. 1. Wall-column structure system of electrostatic precipitator casing and the coordinate system

The geometrical configuration and parameters of the examined wall-column structural system in precipitator casing was based on practical projects. In practical electrostatic precipitator, one span wall plate corresponds to one electric field, and only two spans of wallboards were built in research model so as to improve modeling and computation efficiency. The geometrical structure of the structural system and the displacement coordinate system were shown in Figure 1. Column was the rolling H-shaped steel column. The middle column between the two cross-wallboards was the double limbs column, and the two limbs were connected by connecting wallboard with transversal angle steel stiffeners. For the H-shaped steel column, the x -axis in Figure 1 was strong stiffness axis, and the y -axis was weak stiffness axis. As a beam-column, the buckling of the column in the plane of the wallboard (around the y -axis, which moment acting outside the plane) would present the lateral flexural-torsional buckling. The stability of the middle double limbs column was studied in this paper. The wallboard and the side flange of the middle column were connected by continuous welding. The flange on the side of wallboard was defined as the rear flange and the column flange far from wallboard was the front flange. The web connecting the wallboard and the two limbs were connected by continuous welding. To reduce the calculated length, perpendicular to the wall plane, all the column were

arranged 4 middle braces at equal intervals along the height direction to provide the Y -support. The middle of the double limbs H-shaped steel column was set four connecting channels with large stiffness to provide X -support. The column spacing between the adjacent connecting channels was considered as a calculation span, which value was l_0 , and was the calculated length of the column around the y -axis.

In practical projects, the casing column bore axial pressure which was transmitted by upper connecting beams on column top and transversal uniform loads combined with negative pressure and wind load, which were transmitted from wallboard casing. In calculation process of finite element method, a rigid cover plate was set on the top of each double limbs H-shaped steel column in the middle. A vertical uniform loading was applied on the rigid cover and the axial pressure N was transmitted to the column and adjacent wallboards through the cover plate. The wiring load q was applied on the central line of the front flange of the column. To induce the lateral flexural-torsional buckling of the column, while applying the transversal uniform load, a lateral disturbance load q_d was applied in the form of uniformly distributed load on the front flange side of the H-shaped steel column(as shown in Figure 1), q_d value was taken as $q/1000$.

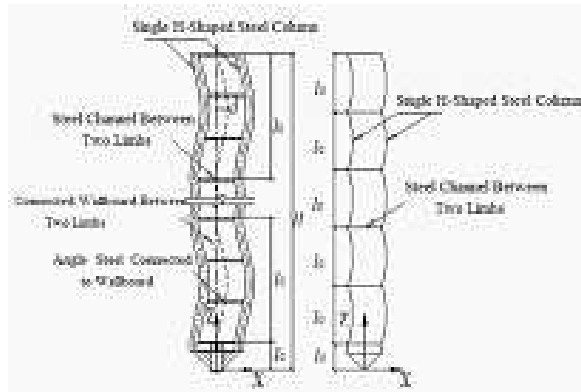
Fig. 2. Initial geometrical imperfection shape of the column

In order to induce the lateral flexural-torsional buckling of the column??considering the influence of the initial geometric imperfections, an initial geometric imperfections in form of a sinusoidal half-wave around the y -axis was applied in the connecting channel area of the middle two limbs of the H-shaped steel column(the connecting channel can be regarded as the lateral support of the H-shaped steel column). The defect form was shown in Figure 2. The defect amplitude δ was valued $H/1000$. H was the height of column.

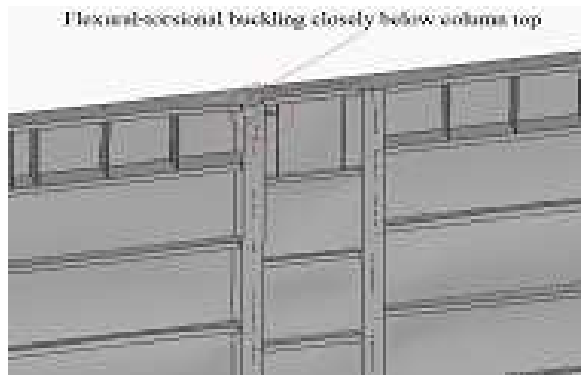
Fig. 3. Buckling mode of the column

The nonlinear finite element analyses were carried out for different configured column under different eccentricity conditions. The failure modes of the beam-column can be generalized into three kinds. The first one was in low e value, the structural response was similar to the axial compression column. For some of the column with smaller interval distance of braces, thicker wallboard and thinner flange, there would be slightly flexural-torsional buckling below the top of the column as

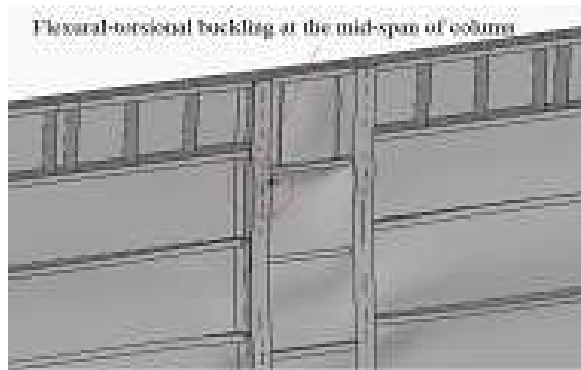
Fig. 4. Buckling mode of the column

The second failure mode was the flexural-torsional buckling at the middle area of the first span of column front flange, as it shown in Figure 4. This was the most favorable failure mode in accordance with the common construction and constant load condition cases of electrostatic precipitator casing column. Under the interaction of axial force and bending moment, the maximum compressive stress was occurred on the front flange of the top of the mid-span, which was away from the horizontal connection of the constraints of the channel and prone to lateral flexural-torsional buckling. When reaching the limit loads there was a large part of the front side of the web and the front flange have reached yield point and buckling. Therefore, this failure mode was named as the elasto-plastic flexural-torsional buckling occurring on the front flange at the mid-span of the top column segment.

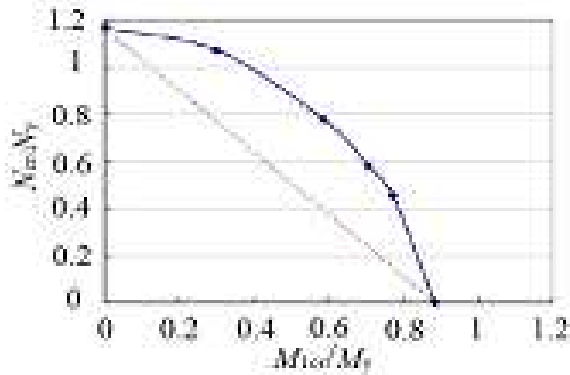
Fig. 5. Relationship curve between N_{cr}/N_y and M_{1cr}/M_y

The response characteristics of H-section steel sections with H294×200×8×12, $b=1120$, $t=6$ and $l_0=3100/\text{mm}$ were analyzed. When the load reaches the limit value, the axial force value was denoted as N_{cr} , and the limit value of the bending moment was M_{1cr} ($M_{1cr}=0.078q_{cr}l_0^2$, q_{cr} was the limit value of transversal uniform load). The relationship curves of relative axial bearing capacity N_{cr}/N_y and relative moment bearing capacity M_{1cr}/M_y were shown as Figure 5. The bearing capacity of the column bore axial pressure independently was N_{ry} and the bearing capac-

ity under transversal uniform load was M_{1r} . The curve shape was convex, which indicates that when the column was under interaction of compression and bending load, $N_{cr}/N_{ry} + M_{1cr}/M_{1r} > 1$. To some extent, the bearing capacity of interactional compression and bending load was greater than that of axial force and transversal uniform load applied respectively. The reason was that, under the axial force, since wallboard shares part of loads, the axial pressure on column section along the height direction of the column attenuates quickly. The region of the maximum response of column was inferior of the top. Under the transversal uniform load, the maximum response of column was the first braced section of the mid-span region. When the two loads interacted, the position of maximum response was different. The maximum response caused by individuals cannot be superimposed. That was equivalent to weakening the maximum response caused by one of the loads. Consequently, the value of the $N_{cr}/N_{ry} + M_{1cr}/M_{1r}$ would be greater than 1.

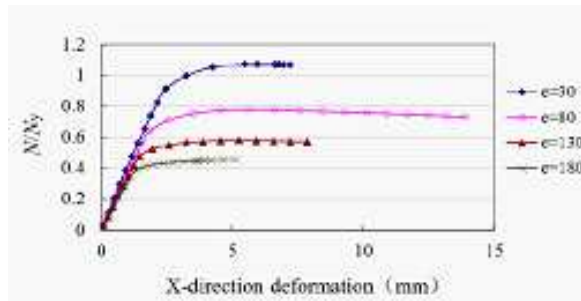
Fig. 6. Relationship curve between load and maximum column X -direction deformation

The maximum lateral flexural-torsional deformation of the column generally occurs on the left limb. In different e values, the maximum X-direction deformation on the column when the load reaches limit point was selected, and the load-X displacement curve was shown in Figure 6. The curve shows that the stiffness of the column in different eccentricity was basically equal at the beginning of loading, and the lat-

eral deformation increases linearly with the loads. Approaching the limit load, the buckling occurs, the lateral deformation was accelerated to increase and the stiffness decreases significantly. After the limit point, the lateral deformation was still increasing rapidly while the load decreases, and the post-buckling performance of the structure was unstable. When the limit load was reached, the maximum X -direction deformation value on the column increased first and then decreased with the increase of e value, and there was little difference.

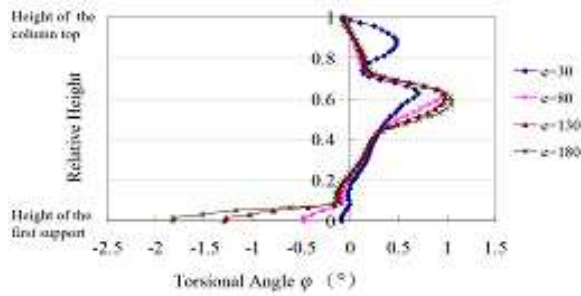
Fig. 7. Distribution of section torsional angle of column along height direction

In different e value, the distribution curve of the section torsional angle along the height of the column was shown in Figure 7. As a smaller e value ($e=30$), axial force dominant in two loads. There were two flexural-torsional buckling occurring, one in the area below the column top ($0.9l_0$ section) under axial force, and the other in the mid-span area ($0.6l_0$ section) under the interaction of axial force and bending moment. Therefore, two torsional angles along the height direction were larger. And there were two buckling half-waves on the column. When e value was large ($e>30$), the control effect of axial force was weakened. Even at the limit load condition, the axial force of the column top area won't cause the flexural-torsional buckling on the front flange. Therefore, only the region of the mid-span occurs flexural-torsional buckling under the interaction of axial force and bending moment,

where there was only one buckling half-wave on the column and the section torsional angle was significantly larger. With the increasing of e value, the section torsional angle of the mid-span increased when it reached the limit point. One side of the front flange in the first braced section below the column top was constrained by transversal connecting channels and the other side was free, where there could be torsion, and the torsional angle increases significantly with the increasing of e value.
