The transformation of burgher houses in medieval Moravia

with respect to
Bohemia and Silesia

Spisy Archeologického ústavu AV ČR Brno 72
Editor-in-chief: Balázs Komoróczy

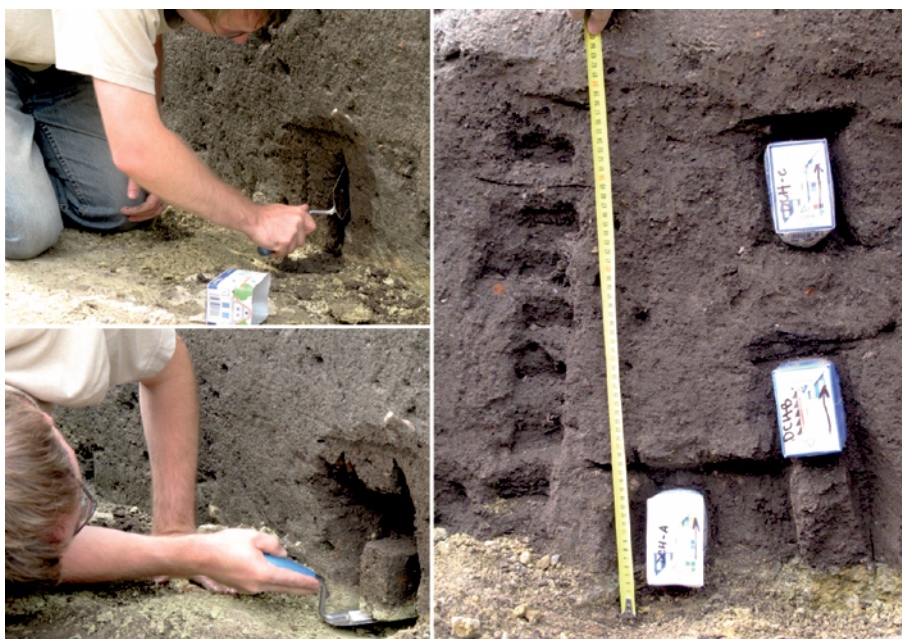
Fig. 1. The way how to sample the micromorphological blocks from the section. Photo by P. Lisý.

Sampling methods vary depending on the type of material collected. The most suitable material for sampling is usually sorted dusty or clayey sediments (e.g. loess or fine-grained fluvial sediments). From these sediments, it is usually possible to ‘cut out’ a cube (Fig. 1) of the sediment without the need for any supporting sampling structure (box). In the case of sandy and gravelly sediments or sedimentary sets with changing grain sizes, it is necessary to use the so-called Kubiena box (Fig. 1). This is a sampling box named after the founder of soil micromorphology and can be made of thin sheet metal or paper, or, for example, a milk carton. If the exact shape cannot be removed, as this is prevented, for example, by the number of coarse clusters, ceramics or bones, it is necessary to remove a larger amount of material by fixing it in gypsum or gypsum dressings. A stronger bed must be created where the sample remains intact during the sampling. After each sampling, the individual samples must be wrapped tightly in cink foil so that they do not disintegrate or dry out quickly. Orientation and context must be indicated on the samples. If it is not possible to transport the samples to the laboratory, it is advisable to store them in a dry, cool place. Samples must not be mouldy or frozen.

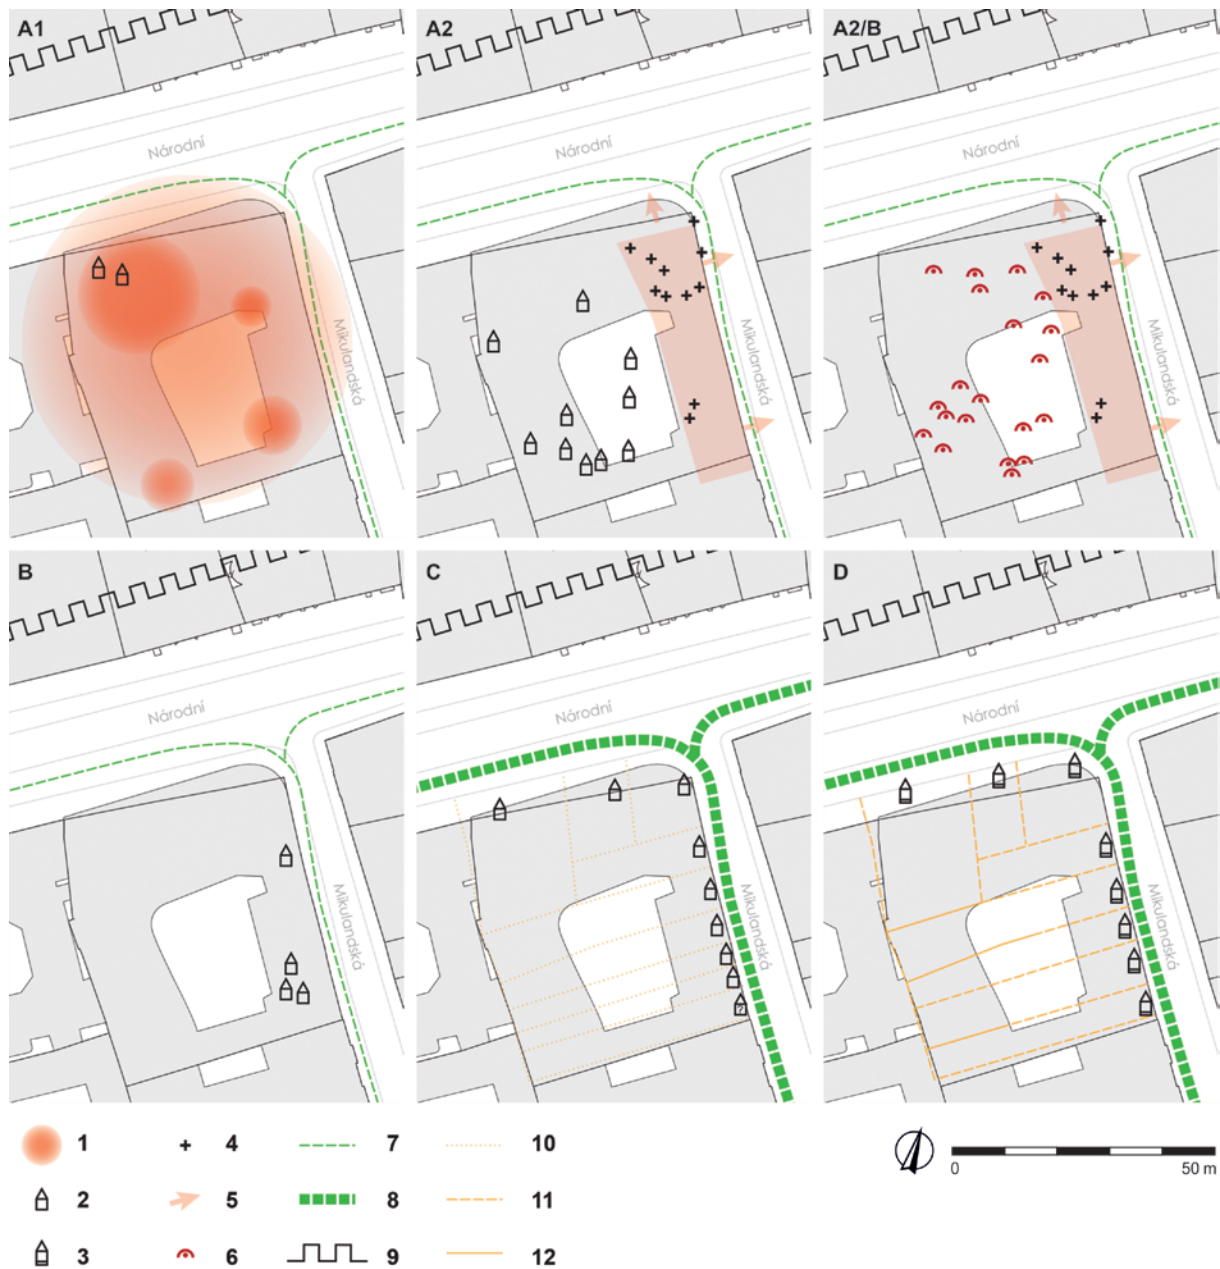
Fig. 9. Prague – New Town, area of the crossroads at Národní and Mikulandská streets (section of the cadastral plan of the city, state as of 2013). Generalised scheme depicting selected manifestations (see legend) of the transformation of medieval occupation at the boundary between the Old Town and the New Town. A1 – pre-urban phase I, ‘earlier settlement’; A2 – pre-urban phase II, ‘later settlement’; A2/B – pre-urban phase II, ‘earlier settlement’ / pre-urban phase III, ‘suburbium’; B – pre-urban phase III, ‘suburbium’; C – early urban phase, ‘young town’; D – urban phase, ‘town and reparcelling’. Legend: 1 – extent and intensity of the oldest settlement; 2 – wood-and-clay and wooden buildings; 3 – cellared stone buildings; 4 – burial ground; 5 – presumed extent of the burial ground; 6 – ironworkers / pyrotechnological structures; 7 – resumed communication / route; 8 – route / path; 9 – Old Town fortifications; 10 – hypothetical plot boundaries; 11 – presumed plot boundaries; 12 documented plot boundaries. Based on the authors’ concept. Created by M. Kalíšek, 2017–2018.

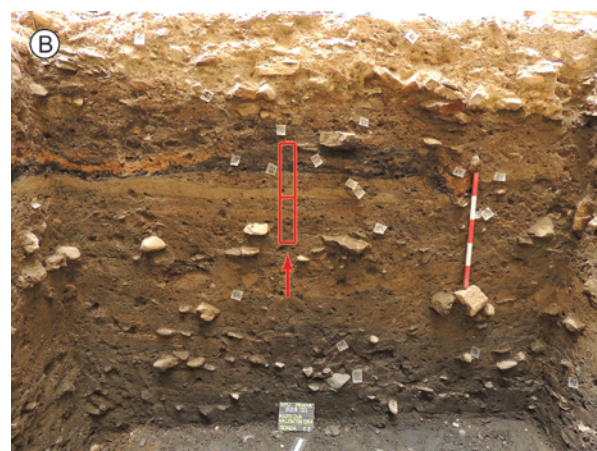
Fig. 23. Location of micromorphological Samples 2 and 3 at the Kaprova site. Author L. Hájek.

Sample 2 was taken from the infill of the recessed house. It is difficult from the archaeological context to say if it is recessed or with above-ground features. Within the archaeological context, the lamination was described as trampling with a thin layer affected by the fire on the very top. Although a set of subsurfaces could be divided in the sample, the distinctions between them were not easily readable, so we describe them as facies A (passive layer of the floor) and B (active layer of the floor) (Fig. 24).

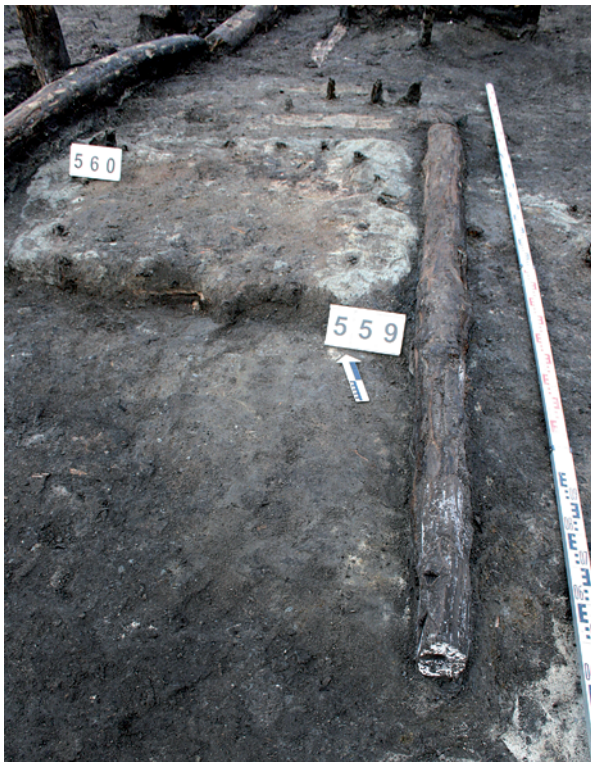
Fig. 40. Wrocław, Nowy Targ Square. Excavations 2010–2012. A clay stove in a log house. Photo by J. Nastaszyc.

renovated by placing a new layer of clay on litter that accumulated in the interior. In one of the buildings, a wooden floor was built on a sand base, and in another one, was only sand layering. Heating devices were discovered in most of the buildings – hearths on a clay plate or stoves. Dome-shaped stoves built on a plan of a circle, oval or square with rounded corners predominated (Fig. 40). These were situated in corners or close to walls, usually on the northern side. The main building material was clay, complemented with bricks, brick fragments and small pebbles. The dome was modelled from clay on a wooden frame made of willow branches. The interiors of the stoves were lined with clay. The longevity of a stove could have been shorter than that of a house. The interior was then coated with new clay and a new stove was built, which covered the relics of the older one.

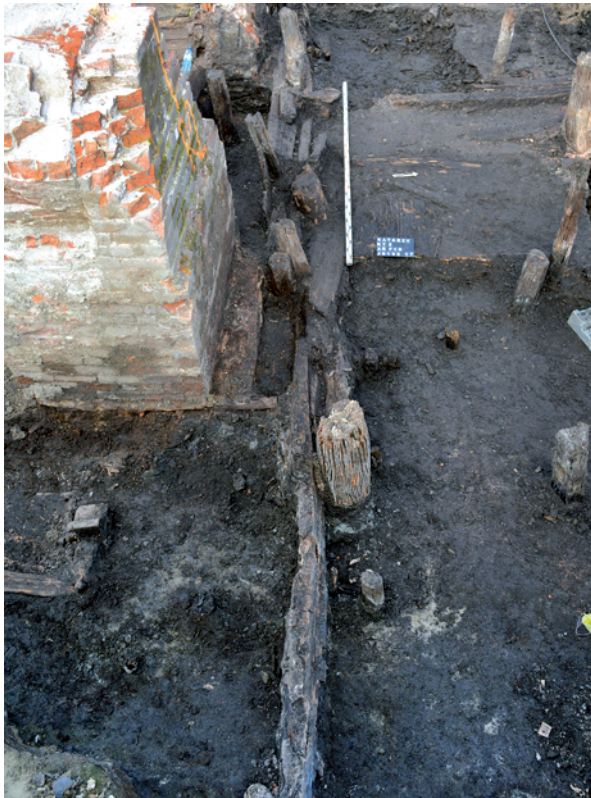
Fig. 43. Wrocław, 2 St Katarzyny Street. A wall in post-log construction. S. u. 196. Photo by P. Duma.

Oder (Kaźmierczyk 1970, 48–52). Their state of preservation is usually poor, and their function is difficult to determine. It is assumed that a post-log building dated to the 1240s–1250s, discovered during the 2010–2012 excavations in Nowy Targ Square, served residential purposes (Fig. 42). In this case, the interpretation is based on the presence of a hearth built from bricks and stones (Piekalski 2018, 239). It is more difficult to confirm the use of post-log construction in houses and utility buildings of the later period, i.e. in the institutional town. However, we know that it was used for building stalls on a market square and sheds on burgage plots (Fig. 43).

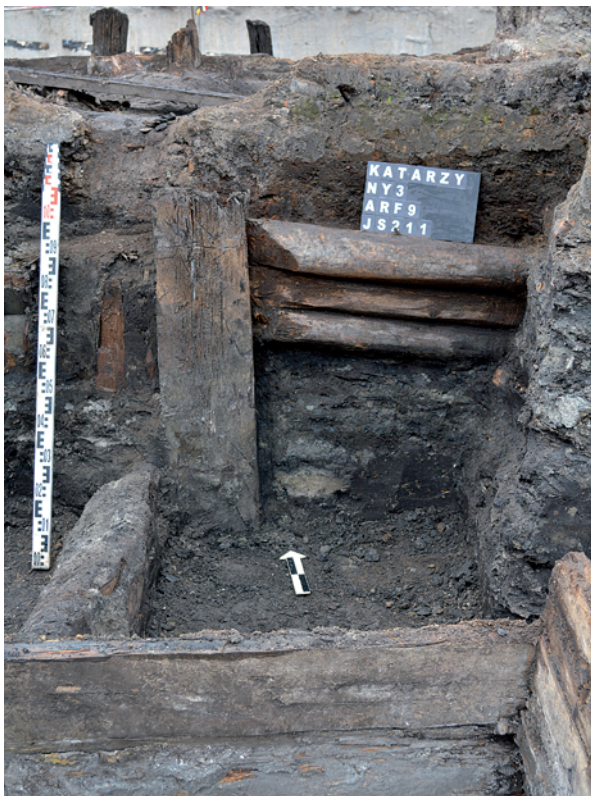
Fig. 44. Wrocław, 3 St Katarzyny Street. A fragment of the wall of a building in a post-and-plank construction. S. u. 211. Photo by P. Duma.

Kaźmierczyk wrote about the post-and-plank construction in Wrocław after he excavated the left-bank settlement (1970, 55). He stated that these types of buildings were rare and dated them to the 13th–14th centuries. They were sporadically recorded in the line trenches on Piaskowa Street (Niegoda 2005, 21–22). This opinion regarding its late chronology in Wrocław was confirmed by the excavations of a housing block situated south of Nowy Targ Square. Poorly preserved relics of seven post-and-plank buildings were recorded there. Three of these functioned in the 13th century, at the end of the proto-urban phase, and the other two in the back of the plots at 3 and 7 St Katarzyny Street (Fig. 44). Until now, we do not have any information as to whether the system was known earlier in Wrocław before the colonists from the West appeared.

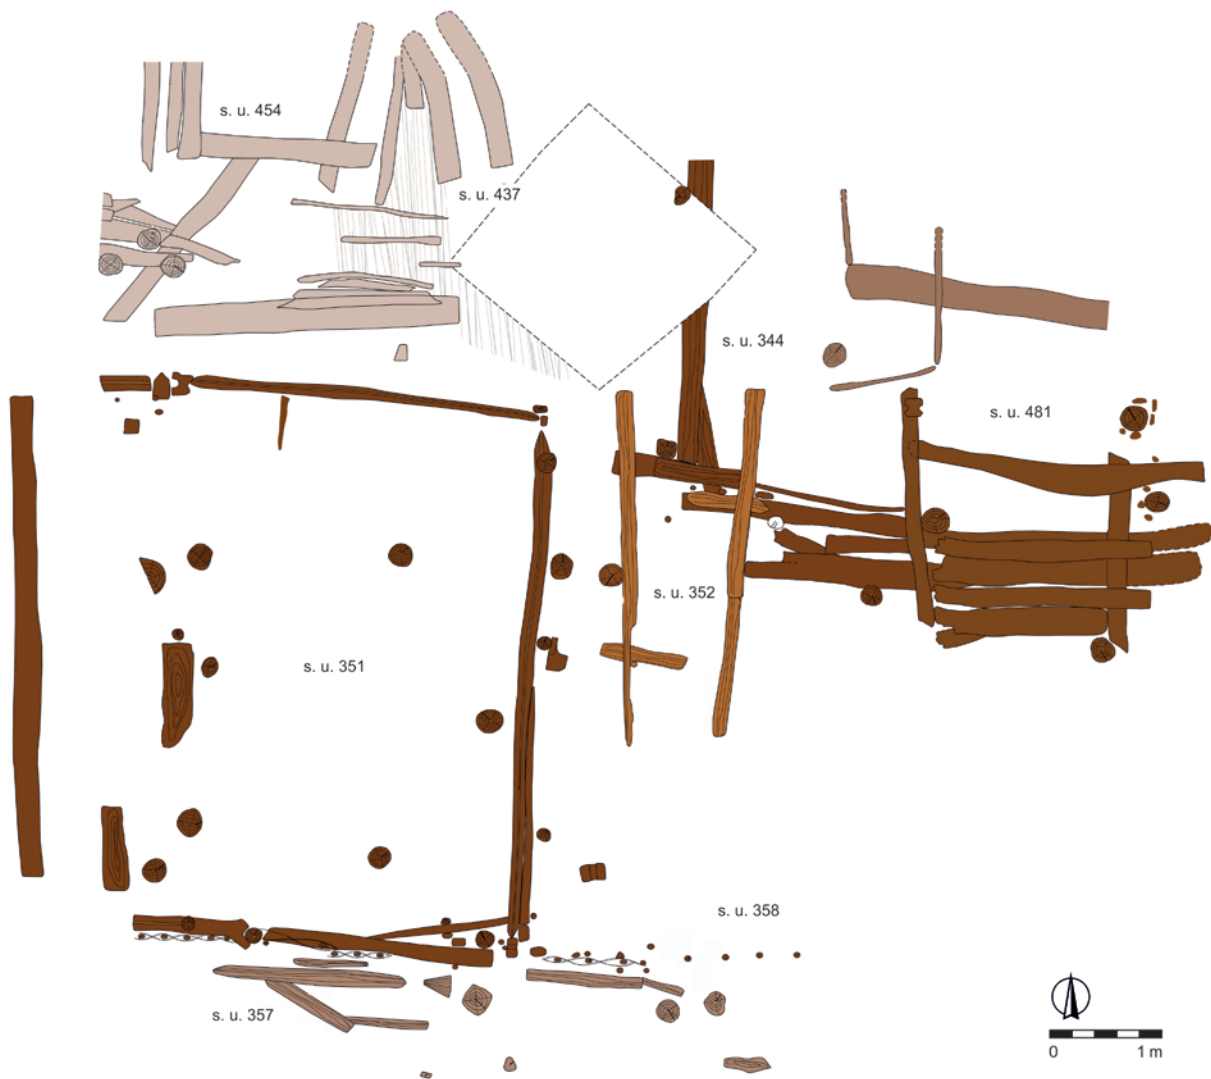
Fig. 46. Wrocław, Nowy Targ Square. Excavations 2010–2012. S. u. 351, plan. Drawing by J. Nastaszyc, N. Lenkow.

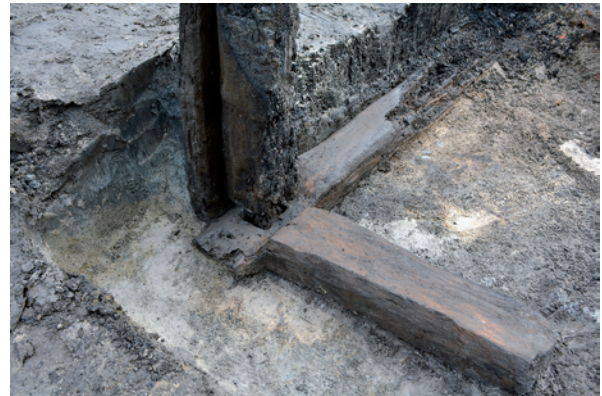
Fig. 49. Wrocław, 6 St Wita Street. Construction details of the northeast corner of a timber frame building. S. u. 247. Photo by P. Duma.

led to the conclusion that reclaimed wood was also commonly used (Piekalski 2016, 118–119). Sill plates had a rectangular cross-section. Well-preserved examples indicate that the size of the edges rarely exceeded 30 cm and the ends were hewn and joined at corners by overlapping. An element that stabilised the corner was a post fixed using a joint in a precisely cut groove running through both ends of the beams, placed on each other perpendicularly (Fig. 51). The posts were placed in corners and the walls. In the case of smaller buildings, two posts in half of the length of the wall were set, and in larger ones, there were several posts every 1.4 m to 3 m. Construction solutions for the upper parts of buildings remain unknown, and we are not aware if and how horizontal beams were installed. In several cases, traces of anchoring diagonal struts stabilising the construction (Fig. 52) were noted. These were fixed in shaft grooves cut in the upper or outer edge of the sill.

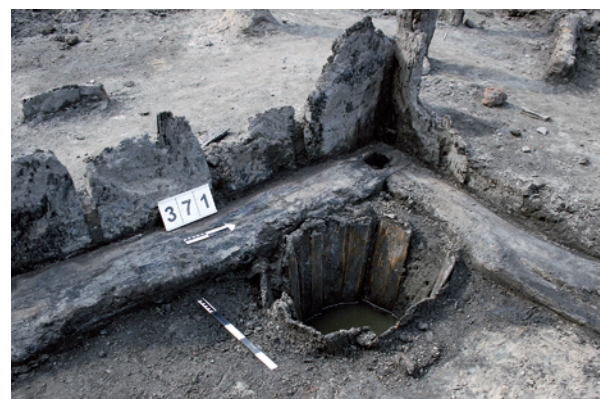
Fig. 53. Wrocław, Nowy Targ Square. Excavations 2010–2012. S. u. 371. Photo by P. Duma.

placed vertically, less frequently horizontally, behind the outer edge of the sill plate and were stabilised by filling the empty part of the foundation trench (Fig. 53, 54). Most often they were set tightly next to one another, edge to edge. Less frequently, planks shaped as wedges placed on one another or the tongue-and-groove technique with a triangular groove were recorded. Sometimes, as in the case of s. u. 332 in the excavations in Nowy Targ Square and at 8 Igielna Street (Nadlergasse), walls were filled with planks vertically placed in a groove made in the top edge of the sill plate and joined using the sublime carpentry technique defined as ‘tongue-and-groove’ (Piekalski 1995, 76–77). Another technique was filling the wall with wattlework, which was placed in a 3–5 cm wide groove cut along the top edge of the sill plate and covered with clay on both sides (Fig. 55; Piekalski 1999, 39). In addition, coating walls with clay was also confirmed as another way of insulating buildings. A visible trace of this technique is burnt

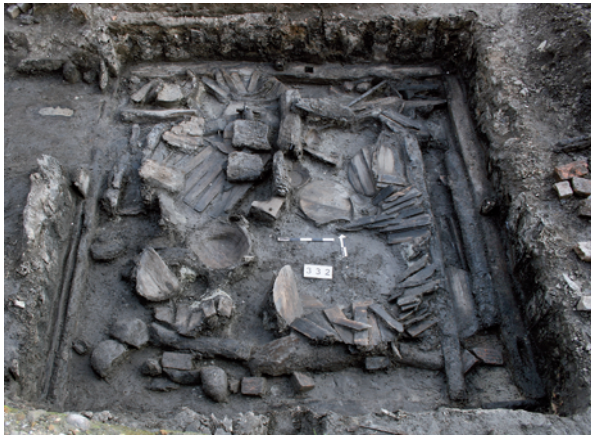
Fig. 60. Wrocław, Nowy Targ Square. Excavations 2010–2012. S. u. 332. Photo by P. Duma.

Further information on the functional division of the interior of the house is provided by a nearby building marked during the excavations as s. u. 332 (Marcinkiewicz, Piekalski 2018, 115–117). It was built on a plot close to a square whose northern wall was 3.80 m long and western wall was 3.90 m with a corridor entrance from the west (Fig. 60). It was set according to the cardinal directions. The trench prepared for the building reached up to 40 cm beyond the walls and was 81 cm deep. Preserved from the construction of the building were 19 cm × 19 cm rectangular sill plates. In the corners, 6 cm × 6 cm notches for the post shafts were cut. The southern sill plate was from 50% destroyed by the fire, so it is difficult to reconstruct its original size. The post

in the northwest corner was 15 cm × 12 cm in the cross-section, 16 cm × 20 cm in the northeast corner and 17 cm × 12 cm in the southwest corner. In half the length of each of the preserved sill plates, further notches for the post shafts were recorded. In the western sill plate, a groove 4.50 cm wide and 3 cm deep was cut. In the groove were only two planks situated at the entrance to the building. The plank adhering to the post in the northwest corner was 26 cm wide and 6 cm thick. It was hewn in the lower part so that it would fit in the groove. The second, 1.34 m from the corner, was 31 cm wide and 6 cm thick. Both planks were construction elements of the entrance doorframe that was ca 1.05 m wide. At the entrance, on the utility level of the building, were the remains

of the 1.6 m high collapsed door, with a preserved key lock. The walls of the building were formed by planks set behind the outer edges of the sill beam, covered later with clay and humus. The width of the planks ranged from 12–45 cm and was 5 cm thick. The planks, charred on the inner side, were usually preserved to the height of 50 cm, less frequently 70 cm. Some of the planks bore traces of being joints using the tongue-and-groove technique. The small planks that were used as tongues were 8–10 cm wide. The interior was lined with river sand. In the north-western corner, the relics of a stove that fell from the second floor during the fire were recorded. The ruin consisted of burnt pebbles, whole bricks and fragments and burnt clay pieces. The presence of the second floor of the building is also indicated by fragments of burnt beams that were previously found in the construction of the ceiling and floor.

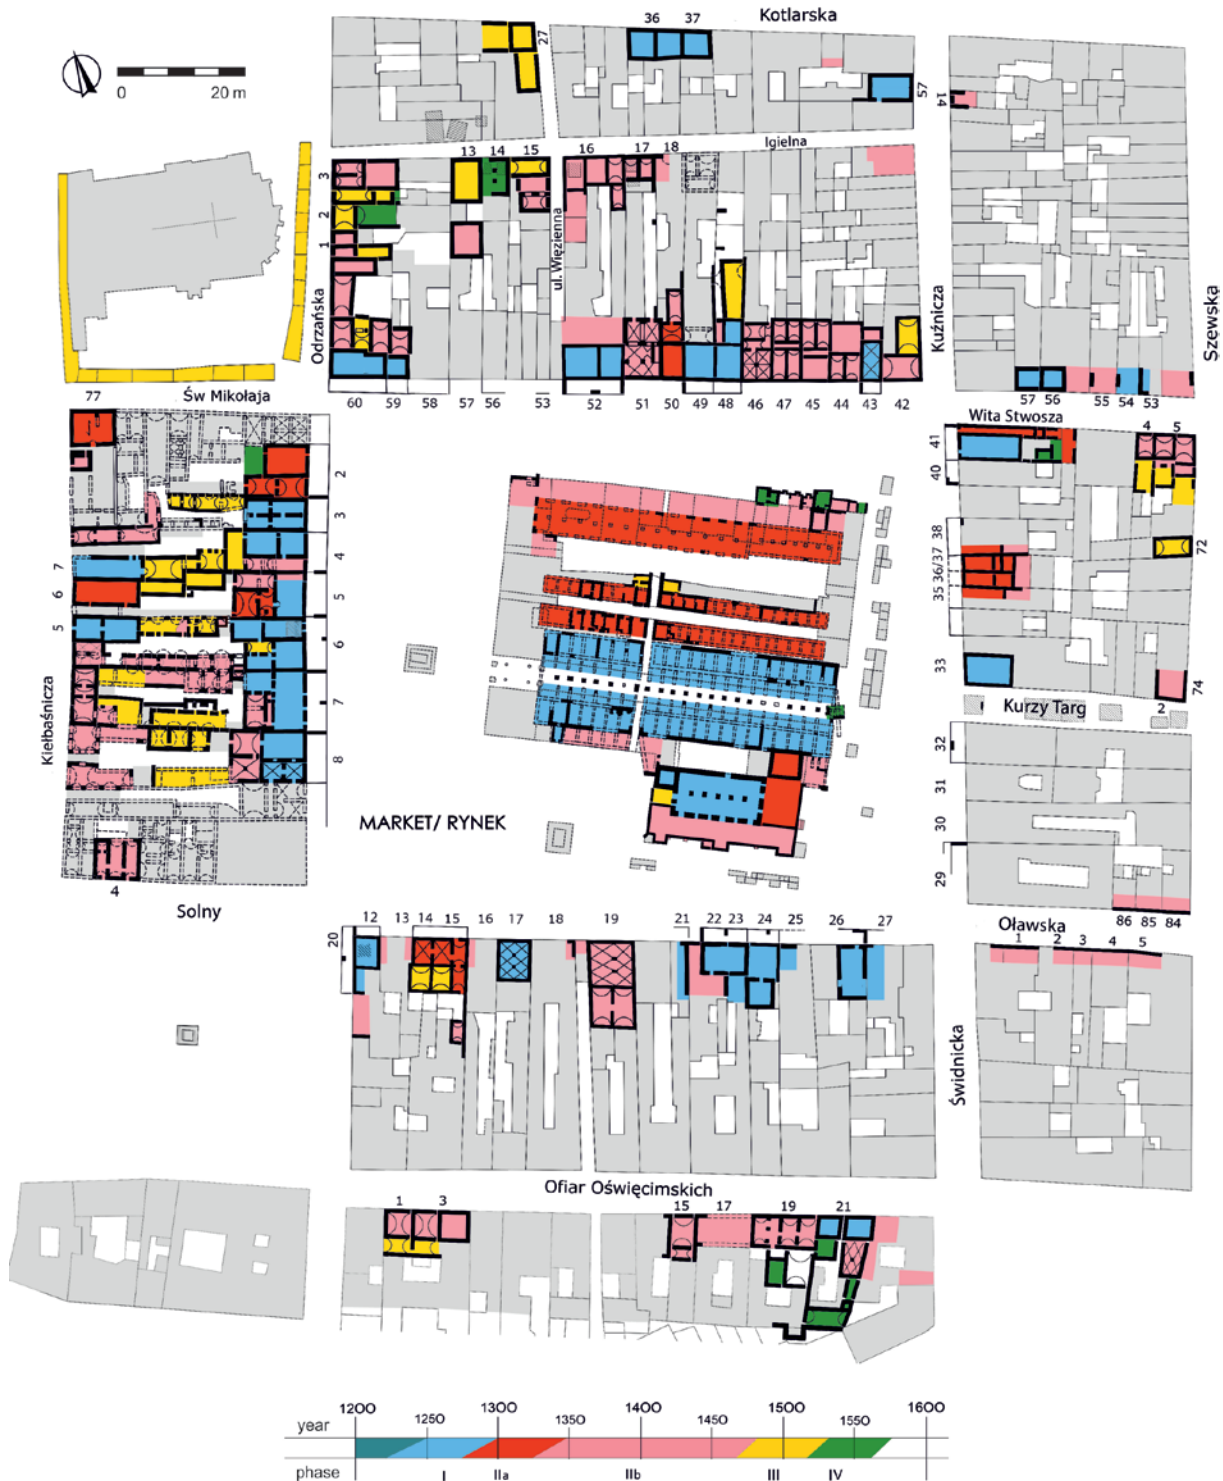
Fig. 72. Wrocław, the vicinity of the market. Built-up development in the Middle Ages and the early modern period. After Chorowska, Lasota 2010, 161, Fig. 105.

the plot fronts were quickly completely built over as the result of the division of plots into halves or three parts. This is why the number of building plots in the market square almost doubled in comparison with the period of the foundation of the institutional

town (Fig. 72). The process of a secondary partitive plot combination took place and was accomplished 'beyond' the boundaries of the original division. Those phenomena, so characteristic of the towns of the intensive economic life, brought about the diversity of the building layout.

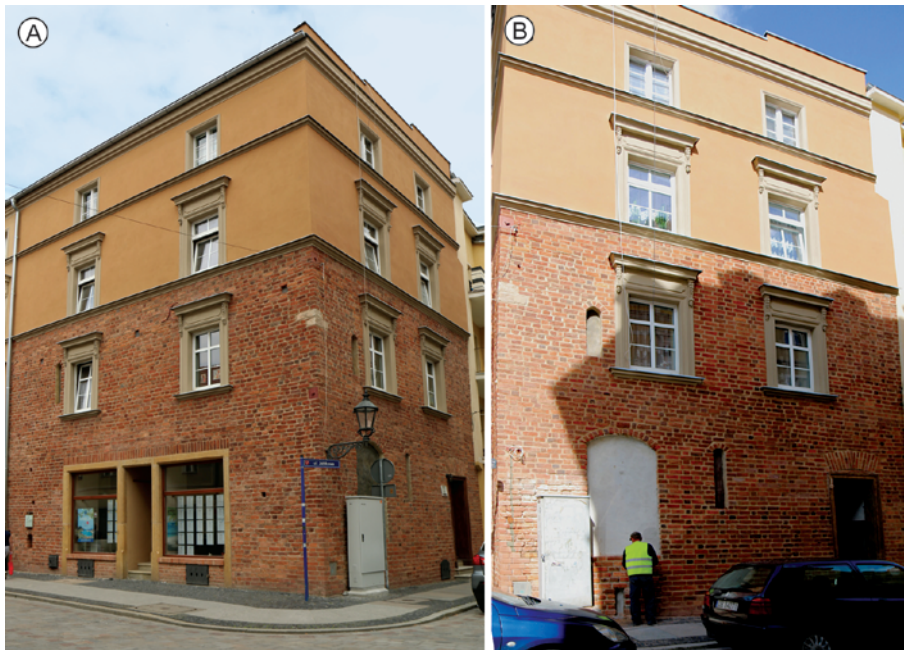
Fig. 74. Brzeg, 6 Jabłkowa Street. Corner townhouse from the 13th century (Vendic way house). A – After conservation works; B – at the time of conservation works. Photo by M. Chorowska.

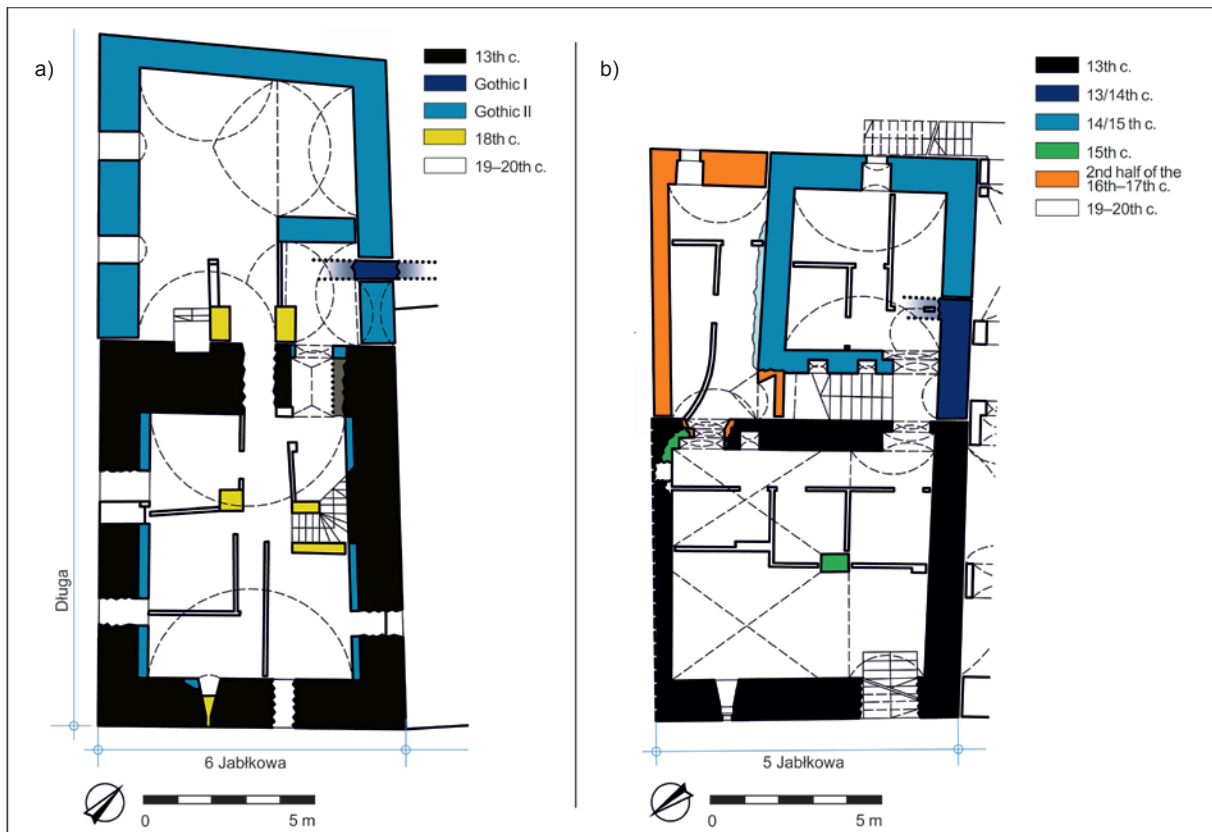
Fig. 75. Brzeg, 5, 6 Jabłkowa Street. Plans of cellars with chronological wall stratification. Preserved walls built in a Vedic way are highlighted in black. After Chorowska et al. 2015, 134, Fig. 3; modified.

If the presence of the Vendic bond is taken as a chronological characteristic of the buildings from the 13th century, then the group of the oldest Silesian tenement houses must be enlarged by a few structures discovered in Brzeg (Chorowska et al. 2015). The closest to them was a brick tenement house in the quoin of 6 Jabłkowa and Długa streets, preserved to the full height of its brick walls (without a possible wooden floor and roof). Its plan corresponded to the townhouses belonging to the group of one-room houses that were half the width (8.64 m) of the plot location (Fig. 74, 75a). In the veduta of Brzeg from 1535/1536, it was depicted as a tower significantly rising above the walls of the old-town townhouses. However, architectural research showed that in the 13th century it had three bricked storeys. This was a standard in Wrocław and was not significantly increased until the end of the Middle Ages. Therefore, the solidity of its tower must have been due to the wooden and clay floors that have not been preserved. The walls of the ground floor were 1.5–2.0 m wide, which made the construction of a few storeys possible. A townhouse, situated opposite at 5 Jabłkowa Street had an analogous one-room plan of a slightly elongated rectangle with dimensions of 8–9 m × 11 m. It was examined only on the level of

the present cellar, i.e. the old ground floor (Fig. 75b). The walls of that storey were built from handmade bricks and faced with the Vendic bond or an irregular one with a visible predominance of stretchers. Bricks with dimensions of 8.2–9.0 × 12.5 × 26 cm joined with lime mortar were used. The ground floor was covered with a beam-framed ceiling. The original 1.5 m entrance led directly from the yard. We came across a similar case in Rynek regarding tenement House No. 7, its neighbours (6 and 8 Rynek) and, although it is not certain, the townhouse at 2 Rynek. In the 13th century, it is highly probable that all those buildings were fully-dimensional, two-storey townhouses as they rose from the very thick walls of the ground floors and were erected in the centre inhabited by a patrician.

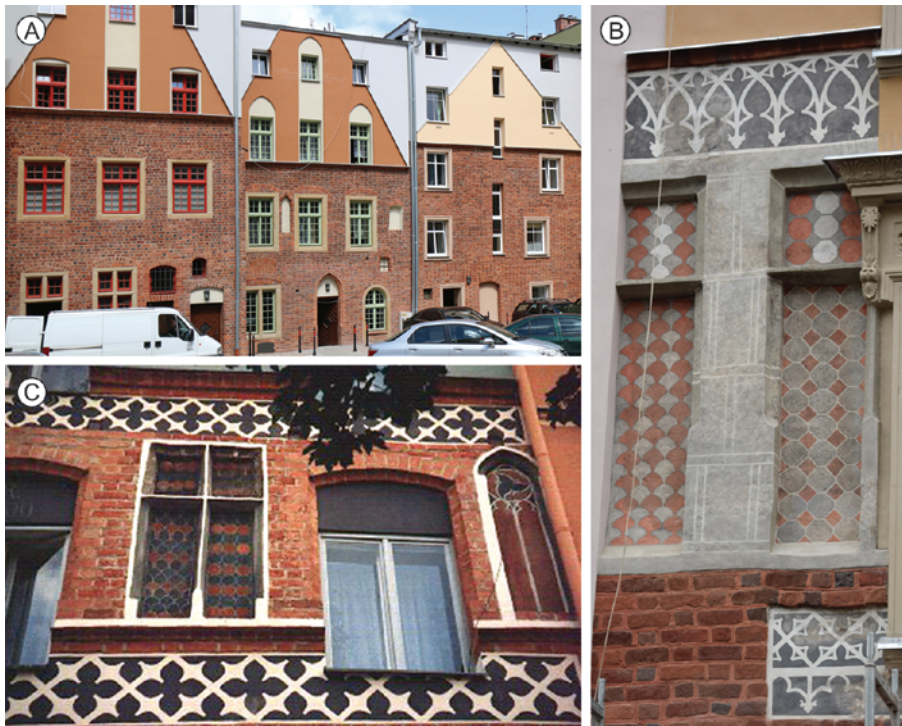
Fig. 79. Brzeg, elevations of tenement houses. A – 8–12 Dzierżonia Street, back elevation; B – 12 Dzierżonia Street, fragment of the facade on the first floor; C – 2 Rynek, facade on the first floor. Photo by M. Chorowska.

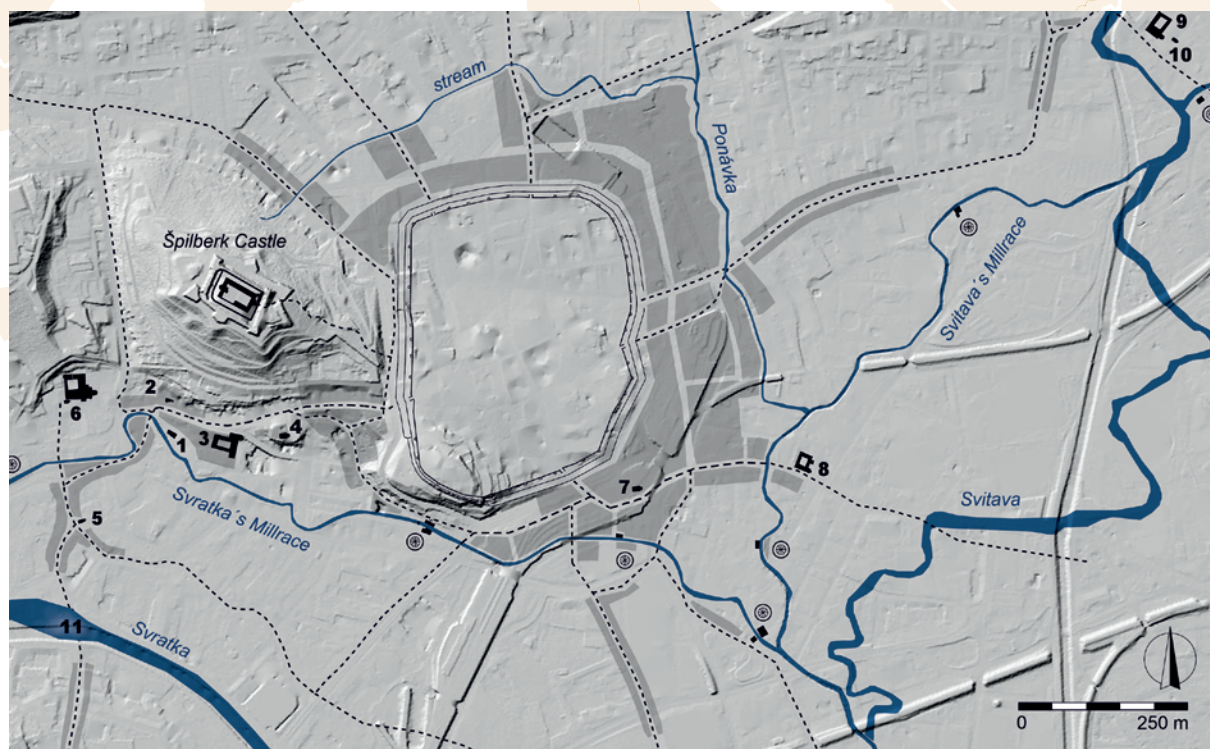
Fig. 80. Reconstruction plan of Brno and immediate surrounding area in the mid-14th century. Dark grey – Brno suburbs and suburban settlements. 1, 2 – Order of Malta commandery with Church of St John; 3 – Dominican nunnery with Church of St Anne; 4 – All Saints Church; 5 – Church of St Procopius; 6 – Cistercian nunnery with Church of the Assumption of the Virgin Mary and Chapel of the Virgin Mary with hospital in Staré Brno; 7 – Church of St Martin (?); 8 – Holy Spirit Hospital; 9 – Premonstratensian abbey with Church of the Assumption of the Virgin Mary in Zábřovice; 10 – Chapel of St Cunigunde of Luxembourg; 11 – ford across the River Svatka with stone Long Bridge. Drawing by M. Peška.

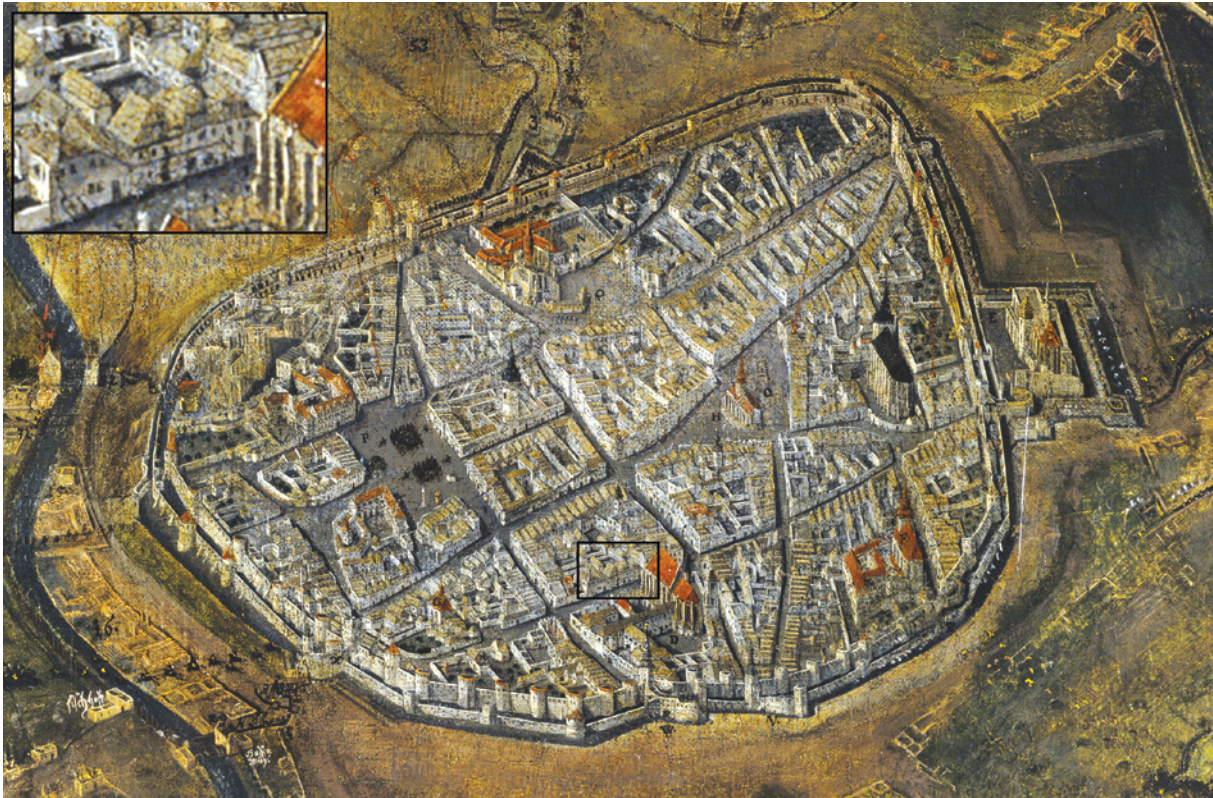
Fig. 82. Brno. Insets from veduta of H. B. Beyer and H. J. Zeiser from 1645. Half-timbered houses are schematically illustrated on the small inset. © BCM.

for example, the layout of the houses, their schematic appearance, the roofing on most of the houses from organic materials, but also the half-timbered upper floors in today's Minoritská Street (BCM; Fig. 82). The situation is even worse with written sources. Mention of a wooden house – *domus lignea* – comes only from an mid-14th-century memorial book (cf. Vičar 1971).

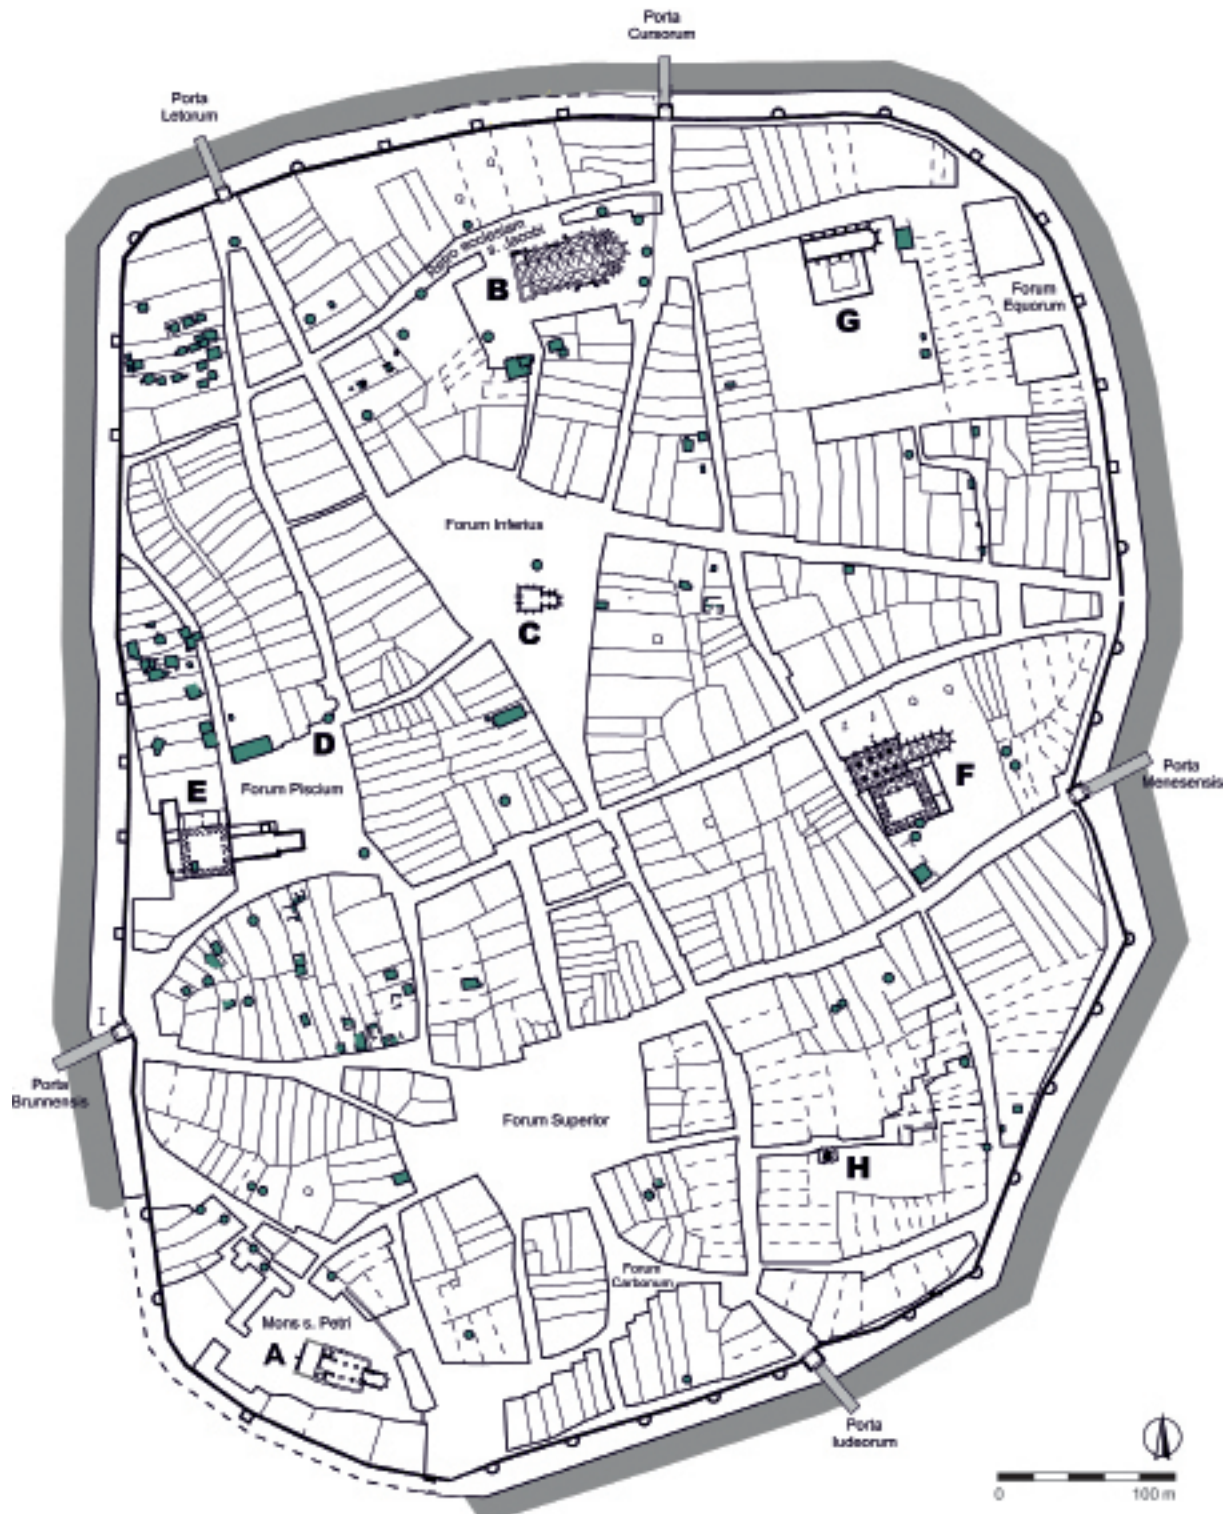
Fig. 84. Brno. Reconstruction of parcellation plan of inner town from the mid-14th century. Green – captured remnants of basements of wood-and-clay houses. A – Church of St Peter; B – Church of St James; C – Church of St Nicholas; D – Royal chapel consecrated to Virgin Mary; E – Dominican priory with Church of St Michael; F – Friars Minor friary with Church of St John the Baptist and St John the Evangelist; G – Herburga convent of Dominican nuns with Church of the Virgin Mary; H – Jewish synagogue. Dark green – finds of basements of wood-and-clay houses. Drawing by M. Peška.

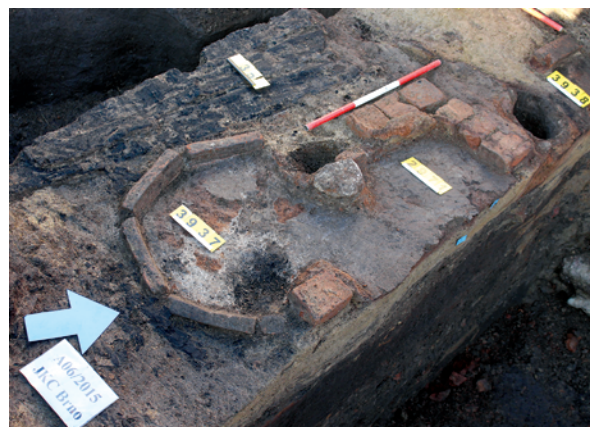
Fig. 85. Brno, Veselá Street. Stove (s. u. 2971, 3937) of one of the above-ground wood-and-clay houses from the 13th century. Photo by Archaia Brno, Inv. No. 27123-2015.

Knowledge of the above-ground parts of buildings is still minimal and in most cases all that is preserved is solitary post and stake holes or the trenches in which they were embedded. A small number of relics of floors are available, mainly involving earth layers with observable ‘walking’ layers and small heating devices of a wide range of constructions. The complete floor plans and precise structural solutions of buildings are mostly unknown. The apparently largest group of these buildings was captured in the as yet unprocessed extensive excavation in Veselá Street (Fig. 85).

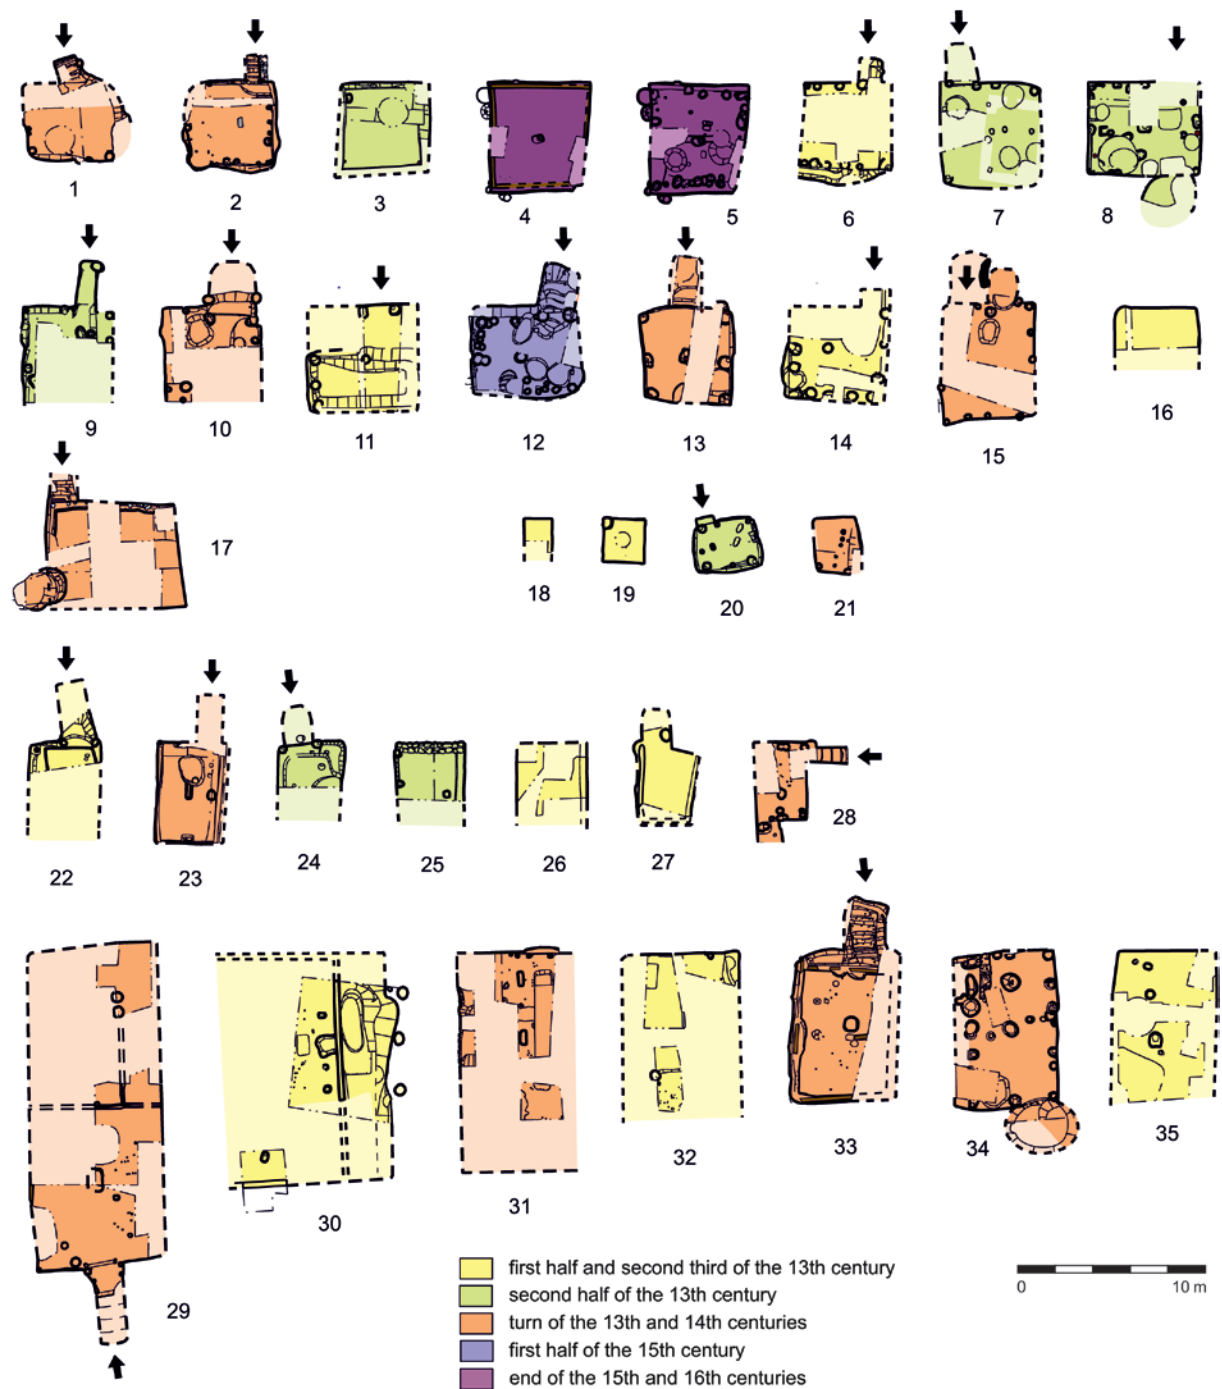
Fig. 86. Brno. Chart of selected floor plans of uncovered basements of wood-and-clay houses. 1 – 1 Panenská Street, Basement 7; 2 – Veselá Street, s. u. g. 2; 3 – Veselá Street, s. u. g. 16; 4 – 1 Panenská Street, Basement 1; 5 – 1 Panenská Street, Basement 1; 6 – 19 Orlí Street, s. u. g. 12, 13; 7 – 7 Dominikánská Street, s. u. g. VS001; 8 – 1 Panenská Street, Basement 2; 9 – Veselá Street, s. u. g. 3; 10 – 6 Starobrněnská Street, Basement s. u. 579/578; 11 – 7 Dominikánská Street, s. u. g. VS010; 12 – 1 Panenská Street, Basement 11; 13 – Veselá Street, s. u. g. 15; 14 – 8–12 Orlí Street, Basement SII (s. u. g. 4); 15 – 6 Rašínova Street, s. u. 549, Basement s. u. 614; 16 – 8 Biskupská Street, s. u. g. 7; 17 – 1 Panenská Street, Basement 8; 18 – 5 Dominikánská Street, s. u. 2504; 19 – 17 Svobody Square, s. u. 550; 20 – Veselá Street, s. u. g. 17; 21 – 1 Panenská Street, Basement 3; 22 – 4 Koblížná Street / 2 Poštovská Street, s. u. g. VS029; 23 – Veselá Street, s. u. g. 13; 24 – 5 Dominikánská Street, s. u. g. VS166; 25 – 5 Dominikánská Street, s. u. g. VS165; 26 – 1 Dominikánské Square, s. u. 531; 27 – 3 Koblížná Street, Basement s. u. g. 5; 28 – 1 Panenská Street, Basement 10; 29 – 17 Svobody Square, Basement s. u. g. 2; 30 – 6 Rašínova Street, Basement s. u. 593; 31 – Mozartova Street, s. u. g. 1; 32 – 4 Koblížná Street / 2 Poštovská Street, s. u. g. VS014; 33 – 1 Panenská Street, Basement 9; 34 – 1 Panenská Street, Basement 6; 35 – 2–4 Starobrněnská Street, Basement s. u. 629. Author M. Peška.

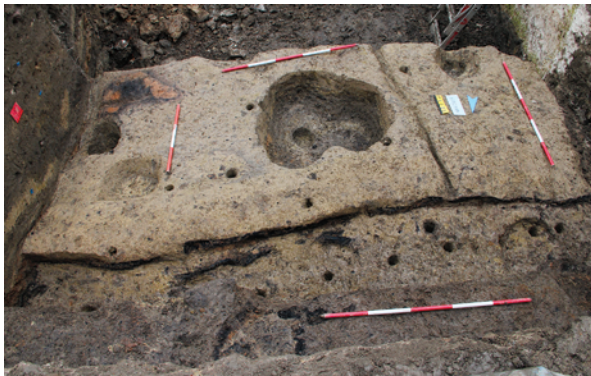
Fig. 87. Brno, Veselá Street. Floor (s. u. 18112) of one of the above-ground wood-and-clay buildings from the 13th century. In lower part a small trench with post holes. Photo by Archaia Brno, Inv. No. 3112-2016.

was significantly wider and shallower (Fig. 87). An analogous situation for the first two cases in Brno is represented by the Building s. u. g. 61 from Trnitá Street, which was a settlement near the city walls in the Middle Ages (unpublished). However, the construction elements here had a diameter of up to 10 cm. The building is a rural house from the period between the second half of the 15th century and the first half of the 16th century that stood at the front of the plot.

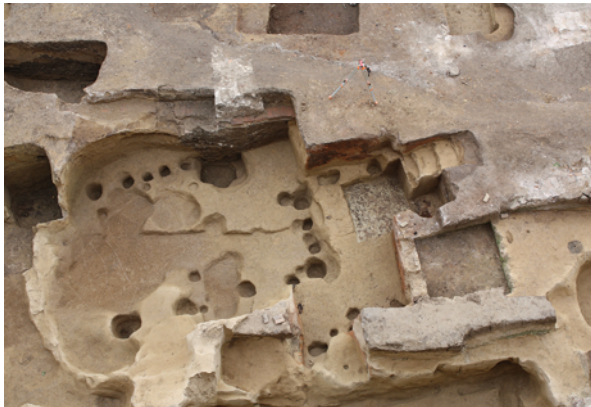
Fig. 88. Brno, 1 Panenská Street, plot No. 501/1. Pit for Basement 11 of wood-and-clay house abandoned in the first half of the 14th century, overall view from above. Photo by Archaia Brno, Inv. No. 16868-2009.

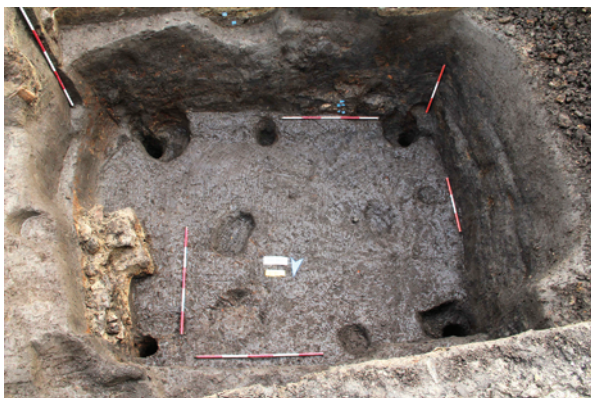
Fig. 89. Brno, Veselá Street, plot No. 593/2. Pit for Basement 17 of wood-and-clay house, view from north. Photo by Archaia Brno, Inv. No. 28666-2015.

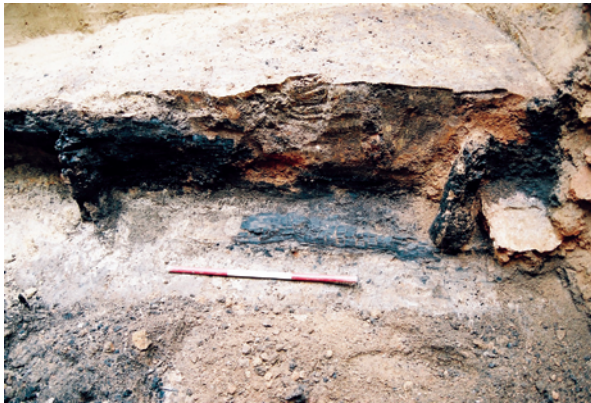
Fig. 90. Brno, 10 Česká Street. Part of wood lining of north outer wall of Basement s. u. g. 15, of wood-and-clay house from the turn of the 13th and 14th centuries with remnants of sill beam and burnt posts. Photo by Archaia Brno, Inv. No. 223-04-33.

The majority of basements had outer walls with a wooden construction, and the space between these walls and the excavated basement pit was backfilled. Wooden elements are preserved in the conditions of the Brno site only in exceptional cases and in a specific natural environment. Occurring more frequently are ‘charred’ elements that have been exposed to heat or elements transformed into distinctly weathered relics, mostly just strips of amorphous peat. The presence of wooden structures is thus most often demonstrated by the discovery of post holes or small trenches for the placement of sill beams. Both of the basic construction techniques described above have been observed in the basements of wood-and-clay houses in Brno. The first involves posts recessed along the walls of the excavated space, directly into the floor of the basement (Fig. 88, 89), whereas the second employs sill beams set horizontally along the lower edges of the basement (Fig. 90, 91). Vertical elements were then anchored to the sill beams, as was positively documented in several cases. Neither of these techniques is exclusively linked to a specific type of basement, either in terms of their dimensions, position on the plot or part of the city. At 8–12 Orlí and 6 Rašínova streets (Fig. 92), the basements with columns embedded in the floor are stratigraphically younger. In contrast, in the case of one of the basements in Panenská Street, the replacement of the original post-built structure with a structure stabilised into horizontally placed beams is observed in the second phase of its existence (Fig. 93). Examples of the apparent simultaneous use of both techniques in the same basement were also recorded. The presence of horizontally placed sill beams in some parts of the basements, the wall construction of which was otherwise evidently made mainly of posts embedded in the bottom, was relatively common (these mostly occur at the walls in corners or at the entrance). The question is whether this is only a separate technical solution or a later repair of the structure. In one of the buildings from Veselá Street, the continuous beams were placed only along the longer walls, while
