The transformation of burgher houses in medieval Moravia

with respect to
Bohemia and Silesia

Spisy Archeologického ústavu AV ČR Brno 72
Editor-in-chief: Balázs Komoróczy

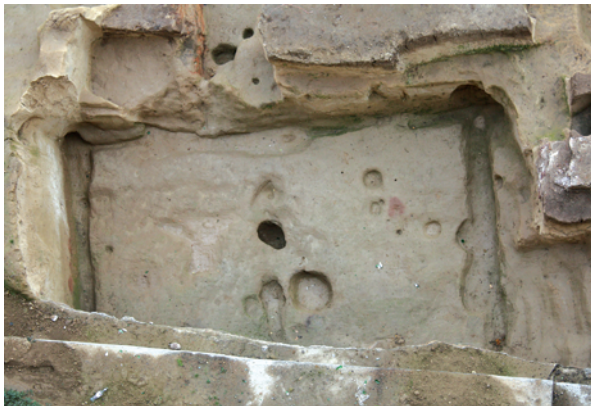
Fig. 91. Brno, 1 Panenská Street, plot No. 501/1. Pit for Basement 9 from the turn of the 13th and 14th centuries. Overall view from above. Photo by Archaia Brno, Inv. No. 18878-2009.

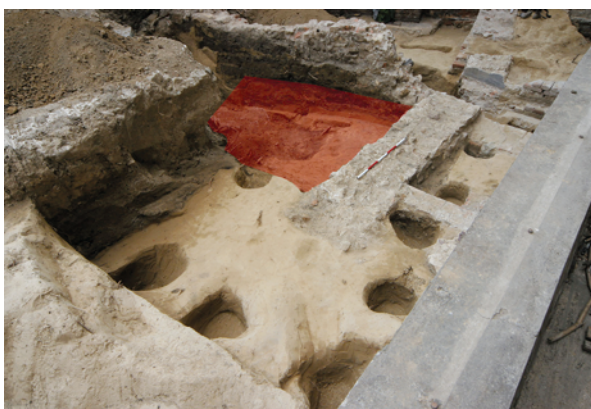
Fig. 92. Brno, 8–12 Orlí Street. View from east towards uncovered parts of Basements s. u. g. 4, 5, of wood-and-clay houses from the first half of the 13th century. Photo by Archaia Brno, Inv. No. 06767-2006.

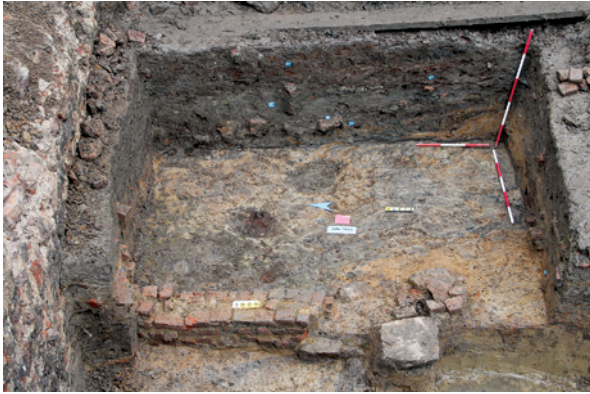
Fig. 94. Brno, Veselá Street, plot No. 593/2. View from south towards fill strata of Basement s. u. g. 5 from wood-and-clay house. Photo by Archaia Brno, Inv. No. 01837-2016.

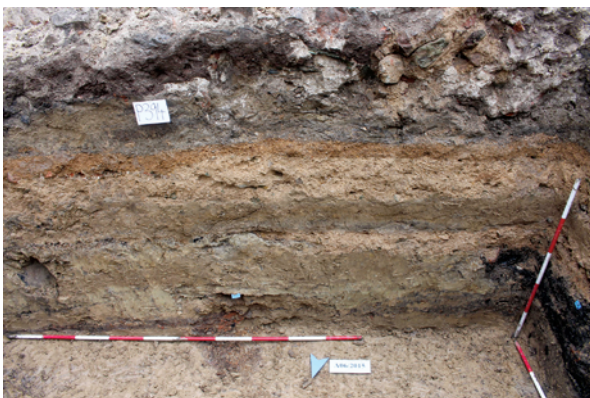
Fig. 96. Brno, Veselá Street, plot No. 593/2. Floor strata of Basement 10. Photo by Archaia Brno, Inv. No. 01662-2016.

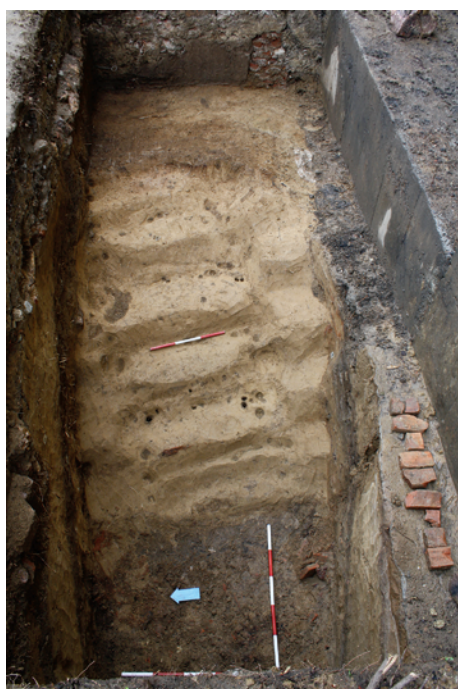
Fig. 97. Brno, 1 Panenská Street, plot No. 501/1. View of uncovered entrance neck of Basement 9 from the turn of the 13th and 14th centuries. Photo by Archaia Brno, Inv. No. 07961-2009.

In the majority of cases, access to the cellars was through an outdoor entrance represented by a pit emerging from the cellar space; ladders and wooden staircases may also have been employed. The term ‘entrance neck’ is typically used for the recessed space outside of the cellar’s floor plan – usually a rectangular pit whose width is commonly in the 1.2–1.8 m range. Entrance necks with a turn are not recorded in Brno and occur only in small numbers at other sites. The bottom of the recessed space is usually slanted, stepped or flat. In some cases, the original steps were flattened by the repeated foot traffic. Elsewhere, attempts were made to prevent this erosion by installing wooden risers secured with

pegs (Fig. 97). In Basement 10 in Panenská Street, a layer of soil was added to transform the original stairs into a ramp. The entrance structures continued into the interior in only rare cases. For example, a one-metre-long ramp made from a block of remaining subsoil extended into Basement of s. u. g. 14 from Veselá Street. However, it is assumed that it was connected to a pit in the exterior. The walls of the entrances were secured by a wooden construction or stone walls built with clay binder or, in rare cases, mortar (Fig. 98). It is even possible that the walls of these entrance pits were not secured (this would mainly have concerned narrow entrances in which a structure would have further restricted movement). The form of the wooden structure was documented in Basement of s. u. g. 2 from 17 Svobody Square, where it was made of boards set behind posts. It is possible that some of the many small post holes recorded in entrance spaces were not only used to secure wooden stairs but could also have been part of the structure of the wattle walls. Multiple phases of changes and repairs were documented in certain entrance necks. The only direct evidence of an entrance being equipped with a gate is the iron fittings present on the wooden jambs in Basement of s. u. g. 2 from 17 Svobody Square. Large iron keys are occasionally found in the fire rubble. It is assumed that entrance necks opened into the interior of the

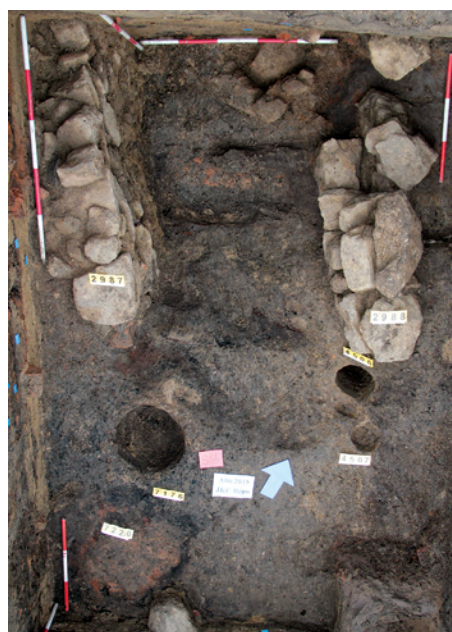
Fig. 98. Veselá Street, plot No. 593/2. View from northwest towards uncovered entrance neck of Basement 18 of wood-and-clay house from the turn of the 13th and 14th centuries. Photo by Archaia Brno, Inv. No. 26913-2015.

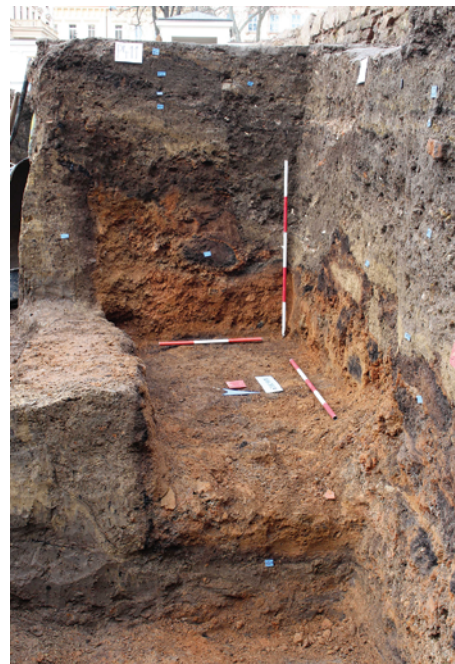
Fig. 99. Veselá Street, plot No. 593/2. View of burnt rubble in the wall of wood-and-clay Basement 9. Photo by Archaia Brno, Inv. No. 2696-2016.

Wood-and-clay houses were abandoned for two basic reasons. The first was a fire, the second the simple removal of the building. A relatively clear criterion for determining the cause is the fill of the subsurface structures themselves, but especially the fire rubble. There were a variety of reasons for the common removal of a house and its subsequent backfill, including new construction plans, a change in the spatial layout, the end of the structure's durability, or a change in the use of a particular area. Nicely documenting the last of these reasons is a case from Rašínová Street, where the pit of an abandoned basement was used for burials as part of the expansion of the cemetery at Church of St James. The spontaneous collapse of damaged or dilapidated structures should also be kept in mind, and it can likewise be noted that the investigated contexts often suggest the dismantling of the wooden construction of the basement walls for secondary use (e.g. the well timbering) or for fuel. Also documented are cases in which parts of the construction elements were discarded in a refuse pit (Merta et al. 2003). In several cases it has likewise been demonstrated that the structure was at least partially left in place, and in very rare cases the use of the basement pits of wood-and-clay houses has been documented in the construction of a Gothic masonry cellar. The basements were typically backfilled in a one-off event, but there are also cases in which the basements were backfilled with waste over a longer period of time, which was why macroremains from the basement fills in Veselá Street were also analysed. These were mainly backfills consisting primarily of redeposited material from the surrounding area (diaspores of rubble site vegetation) and contemporary waste – utility species (Fig. 99; see Chapter 10).

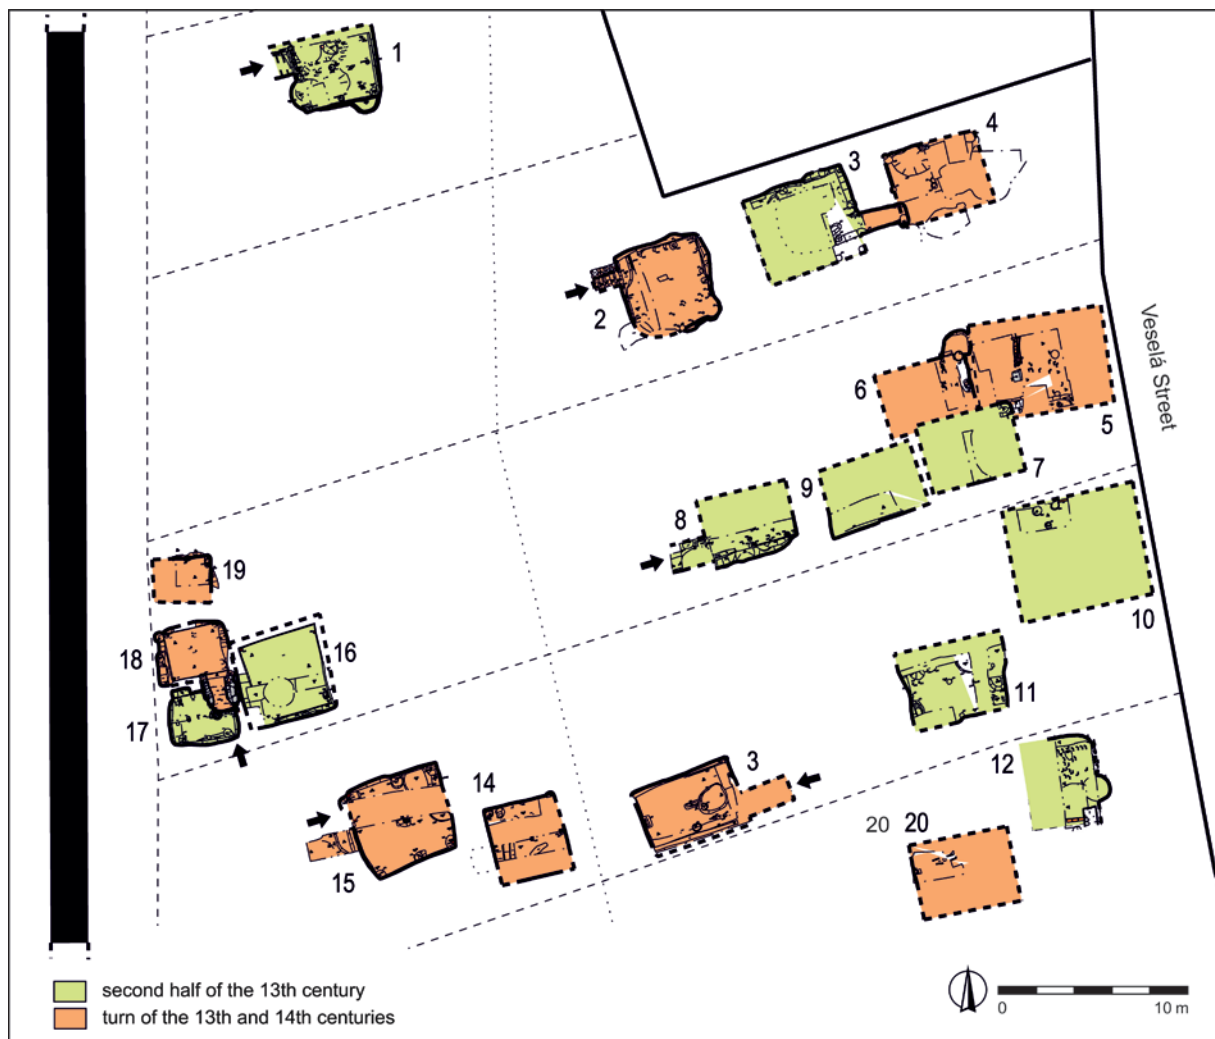
Fig. 103. Brno, Veselá Street, plot No. 593/2. Excavation area with marked basements of wood-and-clay houses. Drawing by M. Peška, A. Zúbek.

No direct evidence exists of the scope and overall form of the wood-and-clay houses of high medieval Brno, in particular, the relationship of the basement with the assumed or existing above-ground part of the house. The question is whether it will be possible to change this situation in Brno in the future. Offering certain hope is a detailed evaluation of the exceptional contexts documented during the archaeological excavations of the former five medieval plots in Veselá Street from 2015 to 2017, which produced an unprecedented amount of quantitative and qualitative information about the above-ground parts of the wood-and-clay buildings (Fig. 103).

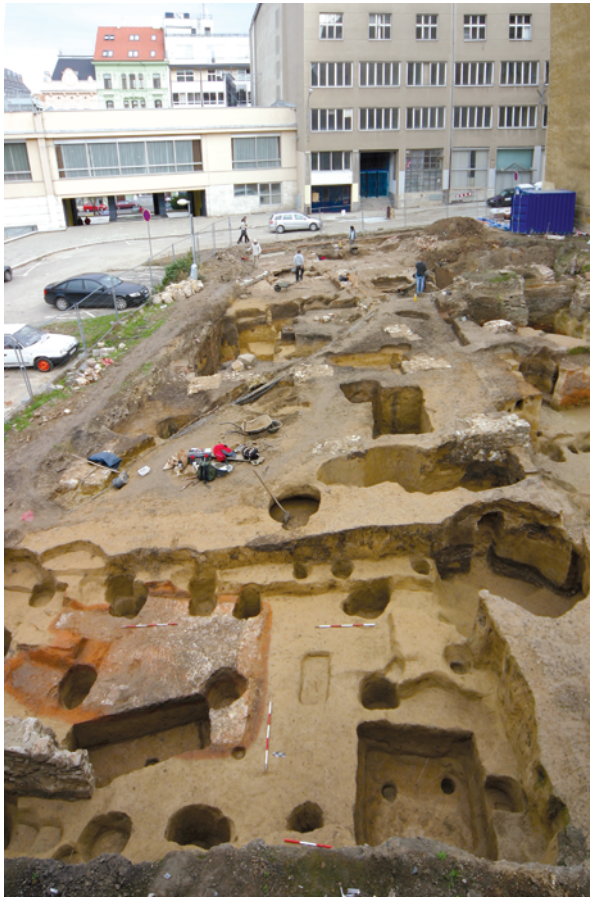
Fig. 105. Brno, 1 Panenská Street, plot No. 501/1. Overall view of ongoing excavation from town walls. Photo by Archaia Brno, Inv. No. 19547-2009.

Chronological questions are connected both with absolute data obtained from dendrochronology and the specific stratigraphic context, including an evaluation of the finds. In many cases in Brno, several basements of different ages disturb each other (e.g. during excavations in Panenská and Veselá streets; Fig. 105), a fact that raises questions about the lifespan of these houses. Dendrochronology, for example, determined that one of the examined houses at 17 Svobody Square was built in 1243 and was destroyed by fire at the turn of the 14th century, as documented by ceramic finds from the collapsed rubble (Procházka, Peška 2007, 209–216). It therefore stood for more than 50 years, which is longer than the generally assumed average lifespan of around 25 years. Absolute dates obtained from wooden and burnt elements used in the construction are from the period 1235–1293 (see Chapter 9). Although the disappearance of the latest basements is dated by ceramic finds to the end of the 14th century, most of these buildings disappeared between the end of the 13th and the middle of the 14th century (Holub et al. 2005a; 2007). While Brno was already dominated by buildings with a masonry core in the pre-Hussite period, wood-and-clay structures did not disappear entirely. Archaeologically documented are the basements of wood-and-clay houses standing in Panenská Street, which disappeared only in the second half of the 15th to the beginning of the 16th century (Fig. 106).

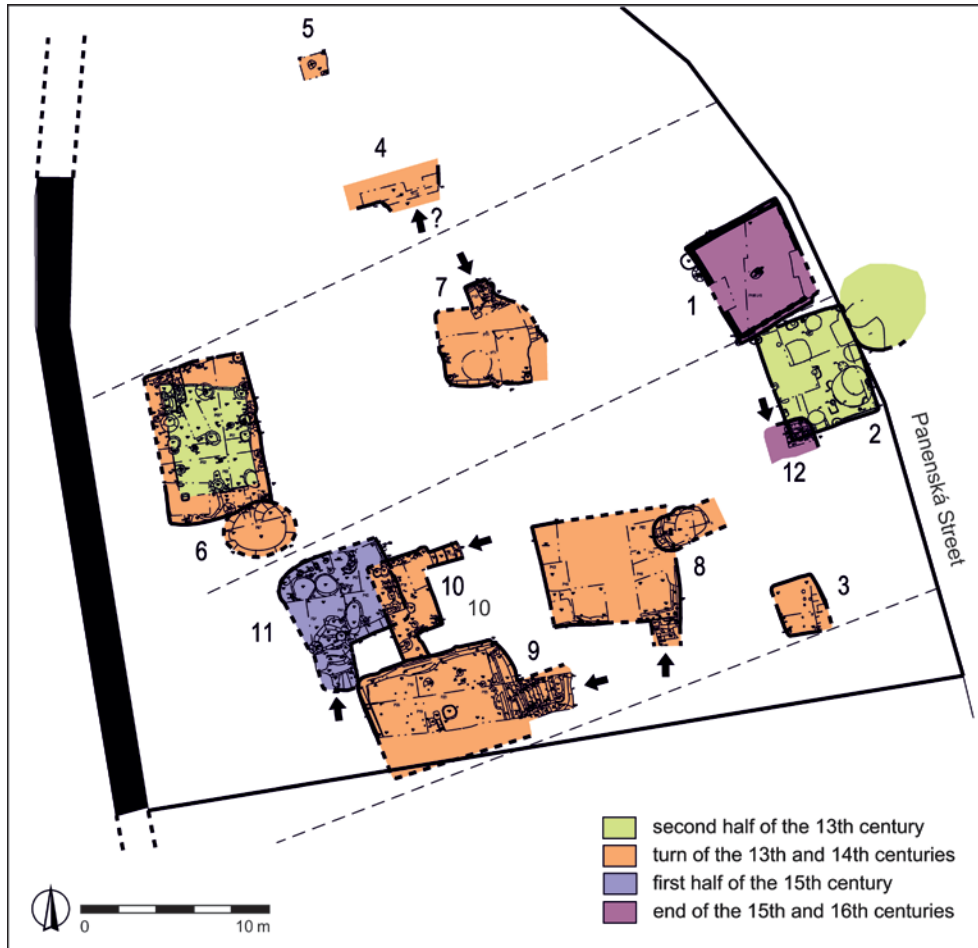
Fig. 106. Brno, 1 Panenská Street, plot No. 501/1. Excavation area with marked basements of wood-and-clay houses. Drawing by M. Peška.

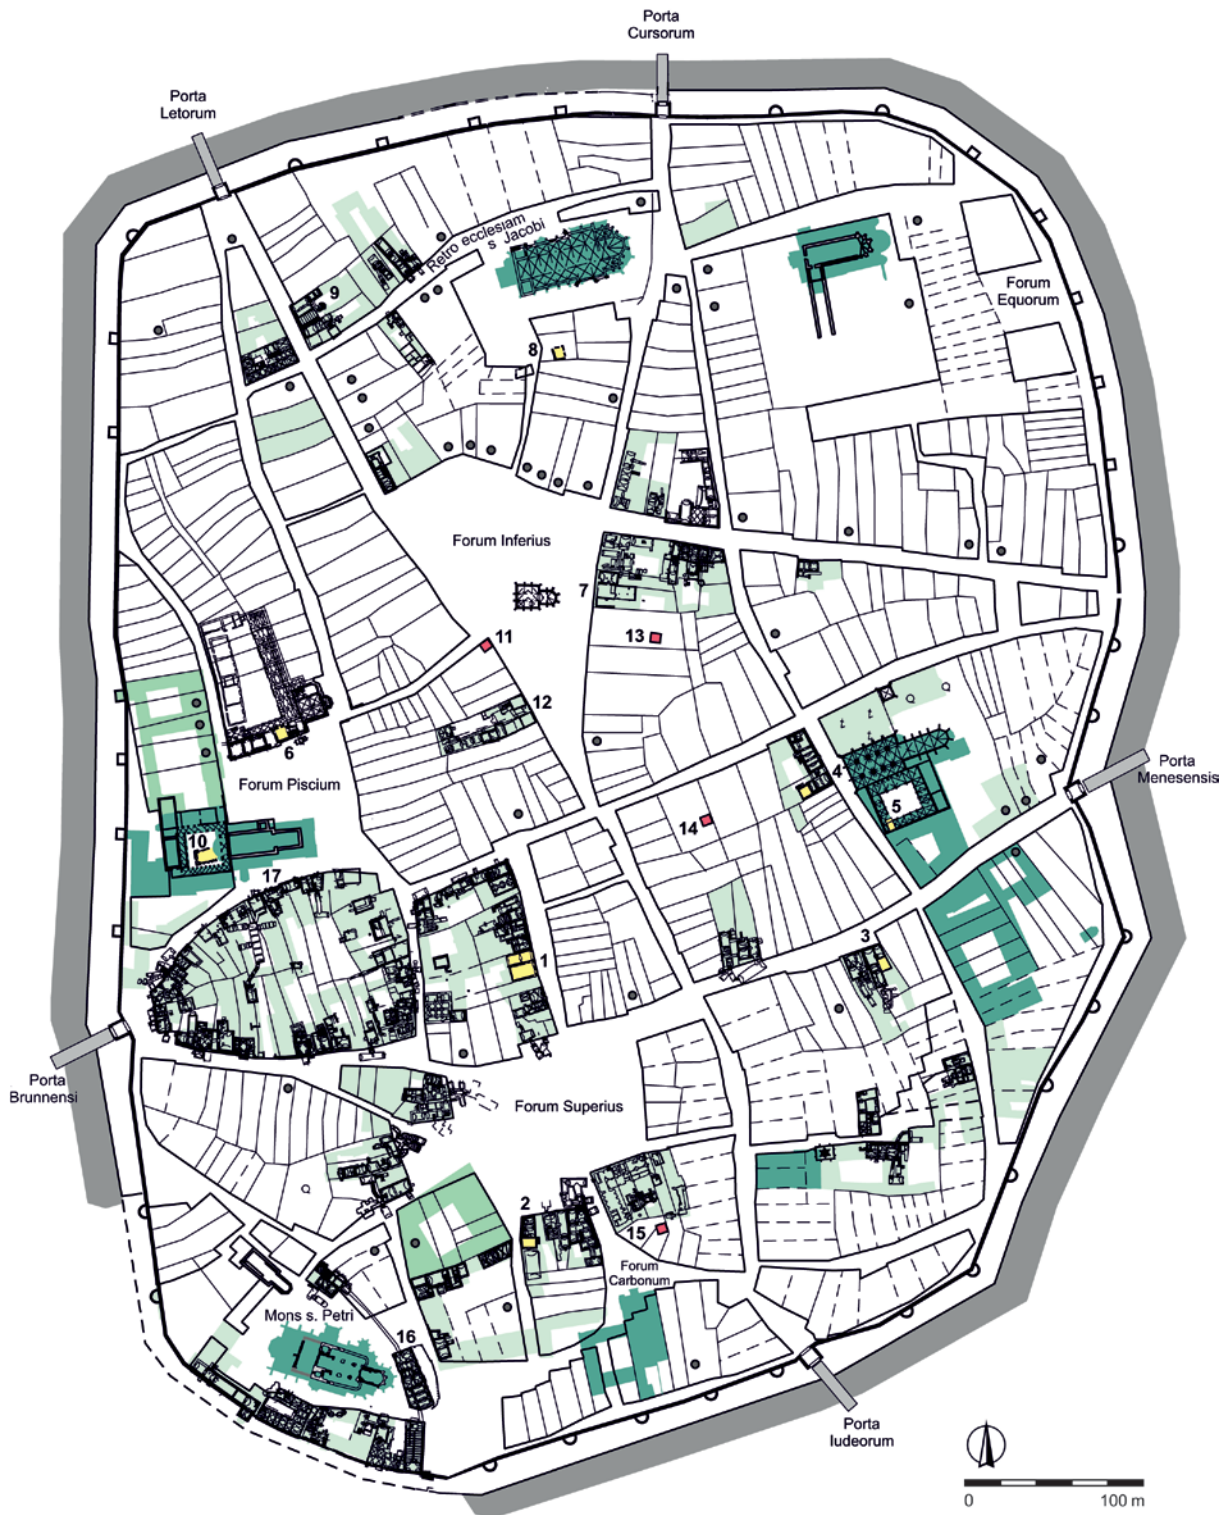
Fig. 107. Reconstruction plan of Brno as of ca 1300 with plan of preserved historical cellar spaces as the background. Light green – preserved historical burgher houses; dark green – existing churches and historical ecclesiastical complexes; yellow – masonry structures demonstrably built in the second third of the 13th century; grey circlets – archaeologically excavated torsos of former medieval buildings; red – defunct tower-like structures. 1 – 8 Radnická Street (Old Town Hall); 2 – 7 Zelný trh Square; 3 – 16 Orlí Street; 4 – 2 Minoritská Street; 5 – Friars Minor friary; 6 – Dominikánské Square – former Cistercian nunnery; 7 – 8 Svobody Square; 8 – 2 Jakubské Square – 4 Rašínova Street; 9 – 10 Česká Street; 10 – former Dominican priory; 11 – 18 Svobody Square; 12 – 17 Svobody Square; 13 – 9 Svobody Square; 14 – 4/6 Jánská Street; 15 – 13 Kapucinské Square; 16 – 2 Petrov hill; 17 – 7 Dominikánská Street. Drawing by M. Peška.

at the turn of the 20th century, during which 238 of a total of 571 buildings were demolished and subsequently rebuilt. The destruction fluidly continued during the 20th century and today only slightly more than 100 historical buildings are still standing, of which less than ten remain without substantial reconstruction. As such, only a fraction of the former burgher development is available today. Greater research interest in Gothic buildings began in the 1960s and continued with greater intensity from the 1980s to the first decade of the new millennium, mainly in the form of building-historical surveys accompanying the reconstruction of the historical urban centre. The result of this research was the identification of a group of ca 130 partially preserved medieval buildings, and these were progressively classified, interpreted and comprehensively described in numerous professional studies (Holub et al. 2007; 2013; Merta 2001; Merta et al. 2004; Merta, Peška 2001; 2010; Peška, Merta 2009; Procházka et al. 2006). Due to the nearly complete rehabilitation of the historical centre, this group can be regarded as essentially closed and any future additions of other buildings will be rare (Fig. 107).

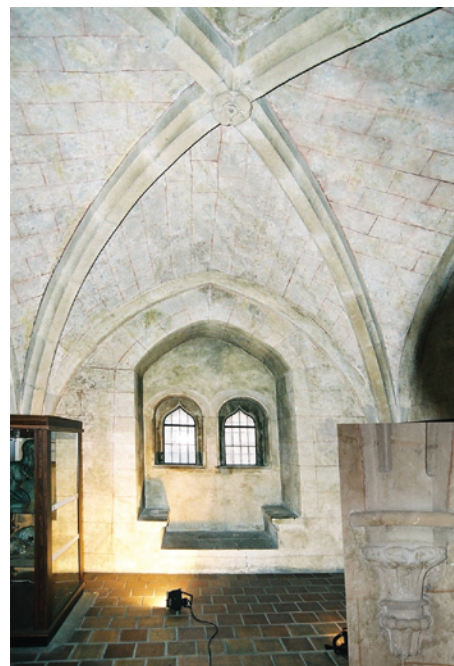
Fig. 108. Brno, 8 Radnická Street (Old Town Hall). Vaulted first-floor chamber with a segment of keystone. Photo by D. Merta.

on the left side a vaulted basement with an entrance from the passageway. The upper floor has a large hall over the basement and two rooms of approximately the same size over the passageway. The building's most significant element is a roughly 5 × 4.5 m 'chamber' with a groin vault with wedge-shaped ribs set on profiled corbels. This space included sedilia (seats) in an opening for an early Gothic window facing the street and a safe in the north wall. An excavation in 2012 also documented a masonry gable and the vault of 'kamenate' from small-format bricks. The building can be dated on the basis of stonemason elements to the period after 1240. It is a unique structure not only for Brno but for the urban milieu in the Czech lands in general. While Brno written sources from the beginning of the 14th century speak of a building called the *iudicium* (courthouse), its location cannot be reliably pinpointed on the basis of period sources. However, it can be identified with the later consistory, which served as an official building where the town council met and the town books were kept, important town documents were stored, the court sat, and where merchants had their shops. The large passageway was undoubtedly used for the inspection of goods and it can be assumed that the building was also a 'mercantile' house belonging to the Brno municipality from its beginning. In its early days, it was certainly one of the dominant features of the newly founded town along with sacred buildings. The dimensions of this building surpass all known early Gothic houses in Jihlava, although the 12-m-wide house at 16 Masarykovo Square at least comes somewhat close to the Brno Old Town Hall. Another interesting Brno house is a two-part building with a cellar at 8 Svobody Square with a separate internal staircase and a semi-circular stone portal in the basement (Kováčik et al. 2001). The layout of this house is conspicuously similar to certain Romanesque buildings in Prague (Dragoun et al. 2003, 71, 113, 123 etc.). Another very interesting and atypical structure is two-compartment vaulted cellar at 2 Petrova Street, which can be dated to the 13th century on the basis of the primary use of small-format bricks. Though clearly with multiple rooms, the above-ground layout of the house is unfortunately uncertain. The other documented houses mostly have smaller dimensions and their incomplete state often renders a reliable interpretation of their former inner layout impossible. Compared to the houses in Jihlava, the absence of early Gothic arcades in Brno is notable. Buildings with a full masonry construction are the foundation of the development of towns in the Czech lands in

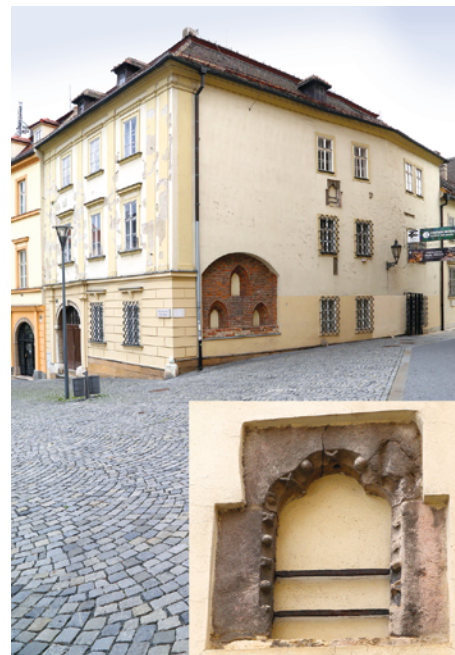
Fig. 109. Brno, 7 Zelný trh Square. Detail of early Gothic window on the second (?) floor. Photo by M. Peška.

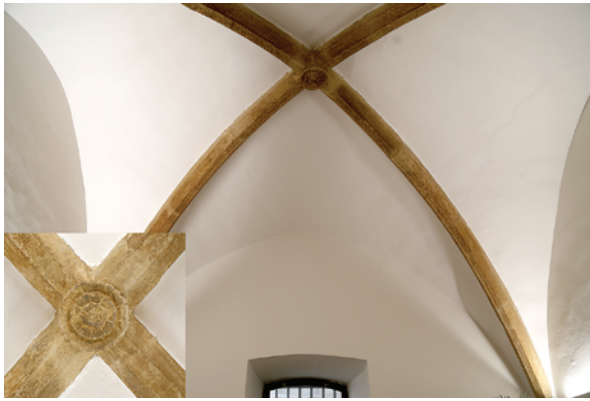
Fig. 110. Brno, 2 Minoritská Street. Vaulted chamber ('kamenate') with a keystone. Photo by M. Peška.

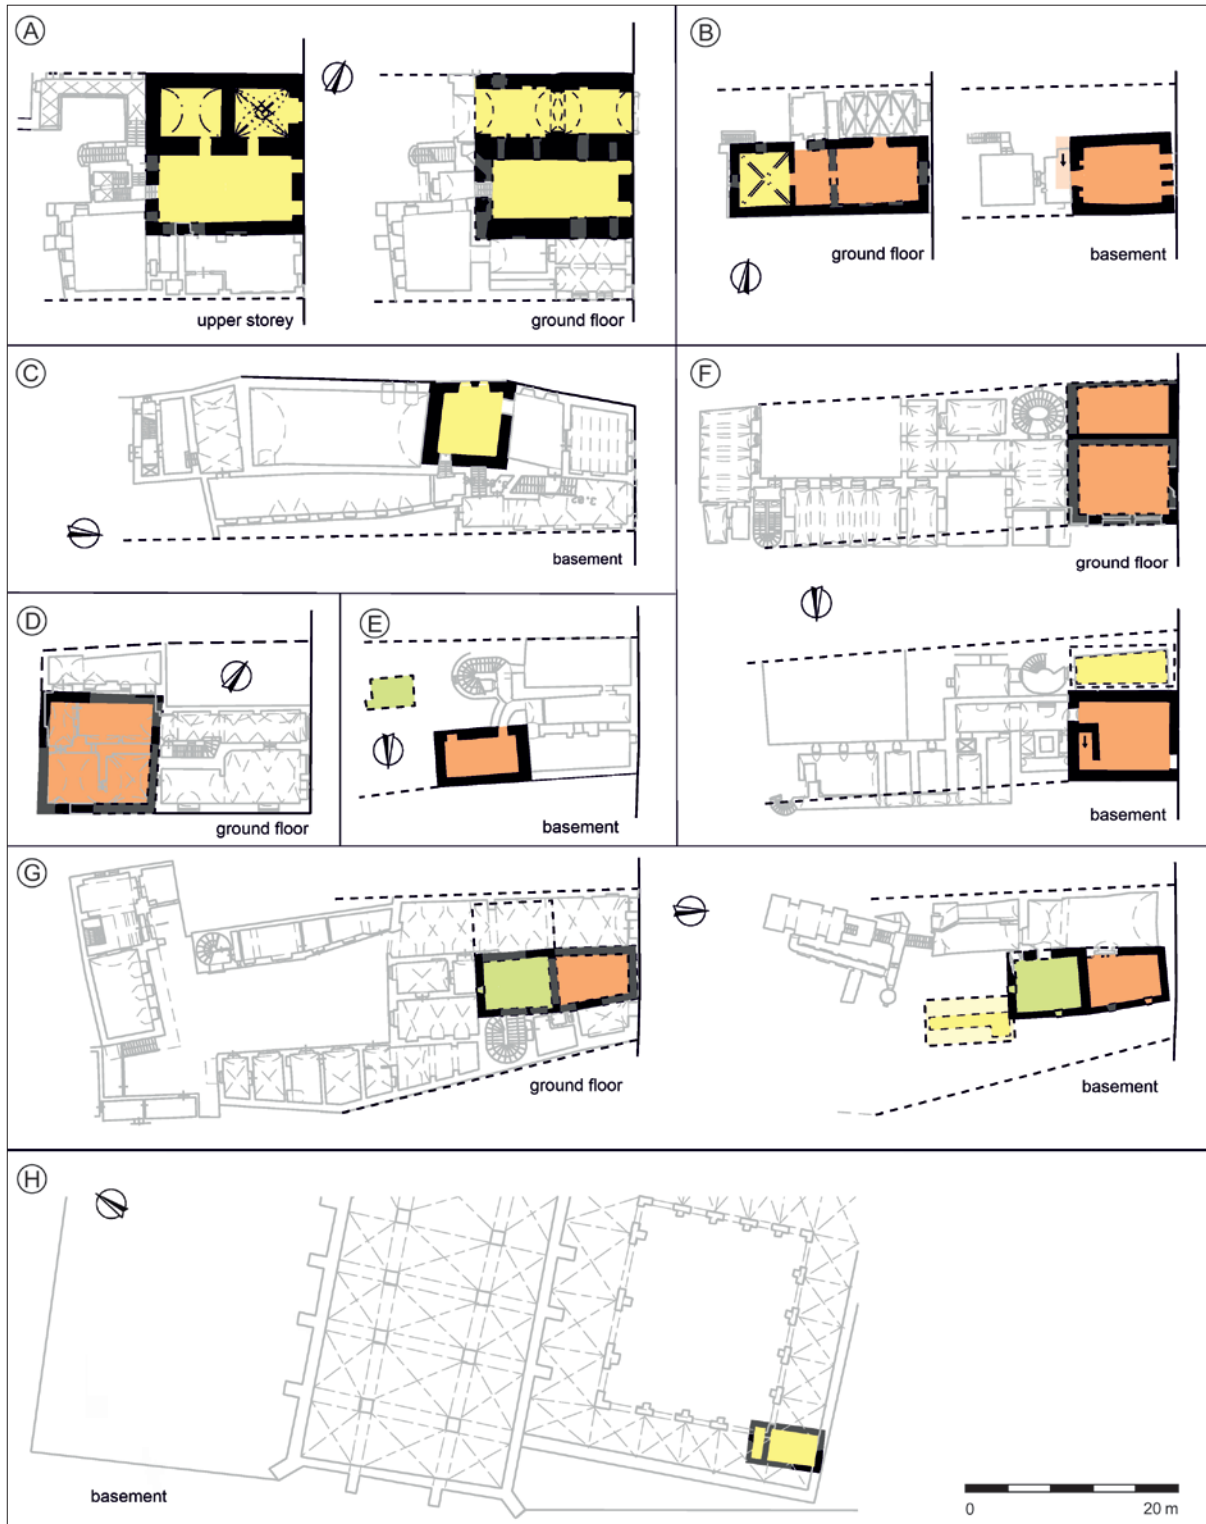
Fig. 112. Selection of layouts and spatial arrangements of Brno's earliest stone houses. Yellow – buildings demonstrably built in the second third of the 13th century; green – after mid-13th century; orange – late 13th and early 14th centuries; A – 8 Radnická Street (Old Town Hall); B – 2 Minoritská Street; C – 7 Zelný trh Square; D – 1 Svobody Square; E – 10 Česká Street; F – 8 Svobody Square; G – 16 Orlí Street; H – Friars Minor friary. Earlier wood-and-clay buildings are also marked with dashed lines for houses E, F and G. Drawing by M. Peška.

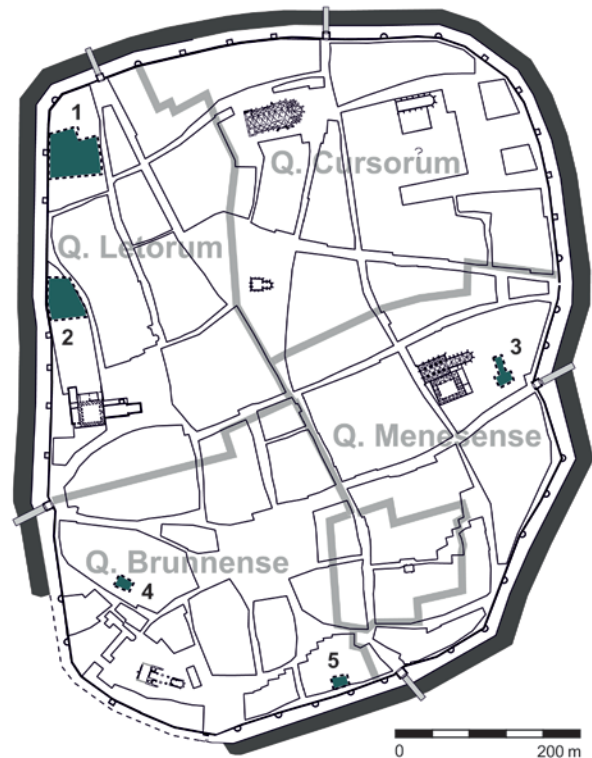
Fig. 113. Brno. Localisation of studied sites and the historical quarters inside medieval Brno. 1 – Veselá Street; 2 – Panenská Street; 3 – Orlí Street; 4 – Biskupská Street; 5 – Bašty. Drawing by M. Peška.

A detailed identification of individual floor sets is published in Lisá et al. (2021). Samples obtained during the rescue excavation carried out by Archaia Brno during the years 2008 to 2015 were processed in this work. They come from a total of five different sites of the former inner city (Fig. 113). Three of

them (Bašty, Biskupská and Orlí) are located in the southern half of its plan, while the plots in Veselá and Panenská streets were situated in the northwest corner of the city centre. The inner city has been divided into four districts (quarters; see Vičar 1965) at least since the 14th century. The examined plots in Bašty and Biskupská streets were part of the Brno Quarter (*Quartale Brunnense*), Orlí belonged to the Měnínská Quarter (*Quartale Mensesense*) and Veselá and Panenská streets belonged to the Veselá Quarter (*Quartale Letorum*; see Fig. 113).

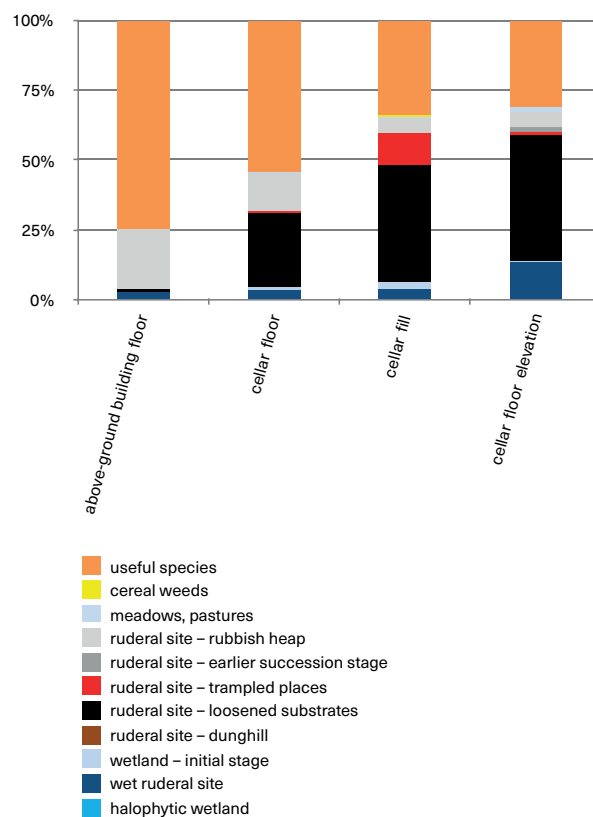
Graph 2. Brno – Veselá Street. Results of the archaeobotanical macroremains analysis, plant macroremains ratios of ecological groups of plants in the individual types of sampled stratigraphic units (n=1,341).

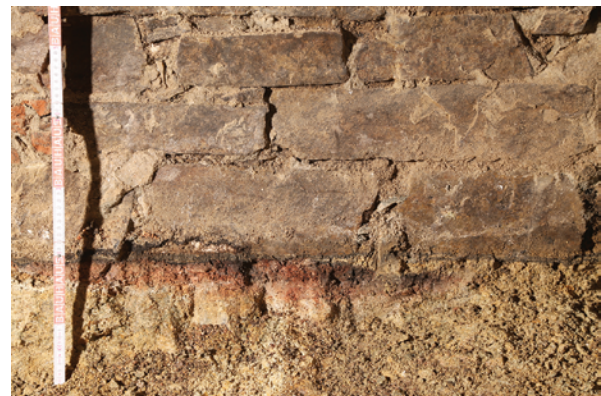
Fig. 120b. Jihlava, 47 Masarykovo Square. View of the floor strata of an earlier wood-and-clay building below the foundation of the Gothic cellar. Photo by Archaia Brno, Inv. No. 28844-2018.

There is evidence of both post-built structures and framing (Hrubý 2009, 69–70). To date, there are no complete layouts available from Jihlava. A particular inspiration for consideration of the appearance of the former houses may come from the contexts excavated in the nearby mining settlement of Staré Hory, which was closely connected with the town (Crkal et al. 2019, 892–903; see Chapter 18). Besides the state of research, the reasons for the absence of a larger number of finds of these buildings may include, for instance, the construction of earlier basements in the place of later stone cellars and their possible periodic renovation. This would be supported by several finds of floor levels or, more precisely, stratigraphies below the foundations of the perimeter walls of Gothic cellars (47 Masarykovo Square, 6 U Mincovny Street; Fig. 120a, b) and trenches after frame structure documented under

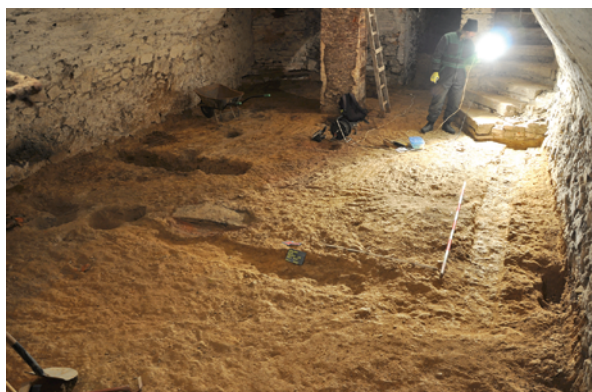
Fig. 121a. Jihlava, 15 Masarykovo Square. View of a cellar floor with embedded trenches for an earlier beam structure of a wood-and-clay house. Photo by Archaia Brno, Inv. No. 23778-2012.

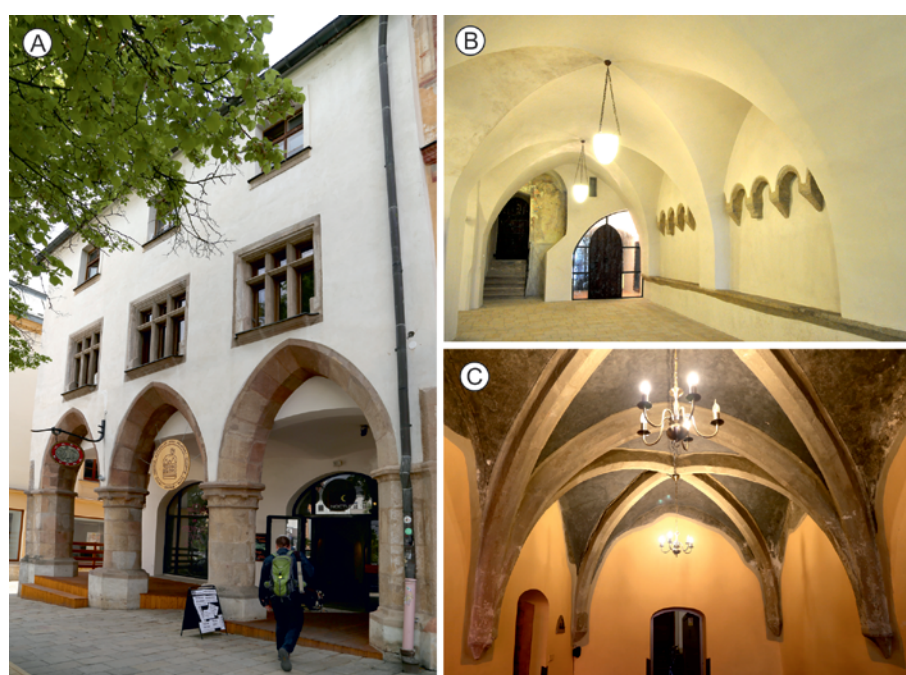
Fig. 122. Jihlava, 39 Masarykovo Square. A – Early Gothic house with an arcade; B – the passageway (after the mid-13th century); C – the vaulting of the chamber (after the mid-13th century). Photo by Š. Kochan.

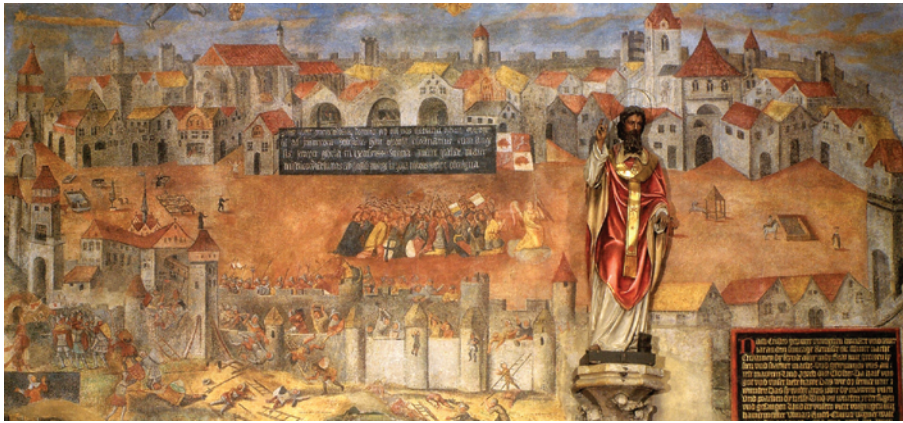
Fig. 123. Jihlava. The fresco of an assault on the town of Jihlava in 1402 preserved on the west wall of the presbytery of the Friars Minor Church of the Assumption of the Virgin Mary. After Hoffmann et al. 2000, map sheet No. 28, Fig. 19.

Olomouc. A fundamental source for the knowledge of medieval buildings is a depiction of an assault on Jihlava in 1402 on the epistle side of the presbytery of the Friars Minor Church of the Assumption of the Virgin Mary. The extraordinarily large, more than six-metre-long fresco was long undervalued although it has recently been proven that it came into existence not long after the fatal event, probably before 1436, as documented by an original inscription in a lower corner. The fresco depicts an attack on the

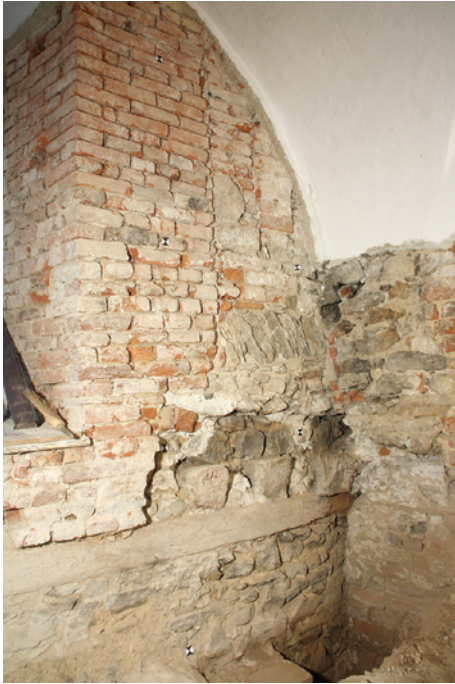
Fig. 127. Jihlava, 16 Masarykovo Square. A view of the south wall of the house with preserved cellar ceiling beams from 1259/1260. Photo by Archaia Brno, Inv. No. 352-2012.

dendrochronology dates (1259/60) have been acquired from the cellar ceiling beams (Fig. 127) and the entrance sill to the underground strongroom in the central part of the house. Judging from this, the construction took place soon after 1260. A depth-oriented rectangular cellar was built in the front part of the house, which replaced a presumed wood-and-clay above-ground building and was added to the rear chamber (‘kamenate’). The new basement was accessible through a long entrance neck from the town square and an angled entrance from the passageway of the house. This latter entrance was fitted with a simple, pointed-bevelled portal situated in the northeast corner of the front cellar. An earlier entrance neck into the ‘kamenate’ chamber was transformed into a small corridor vaulted by a stone barrel vault connecting the front cellar and a newly built square cellar between the front and rear cellars (Fig. 128). This unlit area can be considered as a type of strongroom. The front cellar was illuminated by three small narrow pointed windows directed into a narrow alley. The long entrance neck and the present-day shifted street facade indicate the existence of an arcade. All the basement spaces had flat ceilings, which are perhaps best documented by beams walled into the longer perimeter walls on which the ceiling beams of the cellar were mounted in intervals. The Gothic ground floor was approximately 1 m higher than the present-day level. No above-ground structures of the house or arcade are preserved. This once again leads to considerations of its original wood-and-clay character. In general, it can be stated that the house was three-compartment, depth-oriented with an arcade into the square and a free passageway to the courtyard. The overall length of the house excluding the arcade was a respectable 29.5 m and it was 8.1–8.6 m wide (the ‘kamenate’ protrudes ca 0.5 m from the front part of the house). This means that the house occupied an area of almost 230 m² without the arcade and its usable area on the ground floor was ca 150 m². The front (largest) compartment can be considered a production or trading area (hall). The central part (above the strongroom and the corridor connecting the cellars) was a smoke kitchen with a chimney hood and a small hall interconnecting the front and rear parts of the house. After all, the kitchen remained in this area until the modern period. The rear compartment was comprised of the ‘kamenate’ chamber. The raised ground floor (approximately 1 m) was presumably entered from a low wooden gallery or landing that also covered the entrance neck to the basement in the passageway.

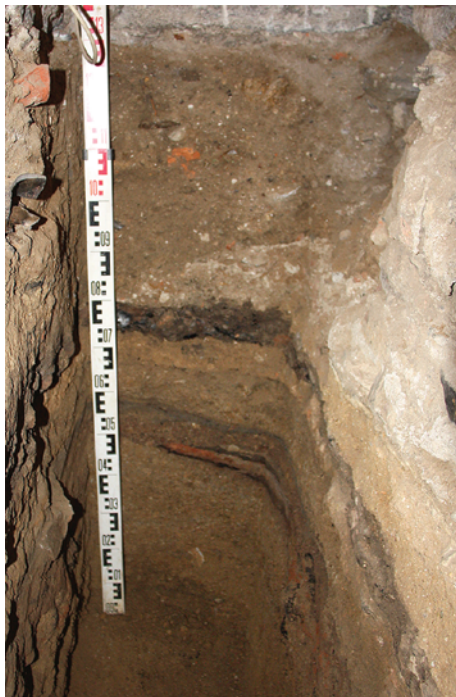
Fig. 131. Jihlava. View into Test pit S10 and Section R1a. Floor strata formed on burnt geological bedrock that was part of vanished wood-and-clay Building s. u. g. 1. Photo by Archaia Brno, Inv. No. 1346-2012.

covered by Mortar layer 143, which is already linked to the construction of the brick house. Considering that the ground level from the 13th century is not known from the immediate surroundings, it can only be estimated based on the floors of the ground level of the stone building from 1260 that the recessed space was relatively shallow, perhaps ca 0.6 m into the former weak soil cover. In order to verify the archaeological interpretations, a micromorphological sample was taken from the floor sandwich.

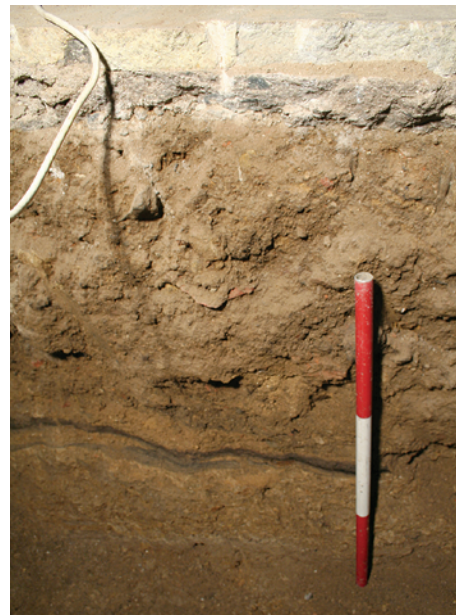
Fig. 133. Jihlava. View into Test pit S14 and Section R2. Floor strata formed on burnt geological bedrock that was part of vanished wood-and-clay Building s. u. g. 2. Photo by Archaia Brno, Inv. No. 1891-2012.

In the passageway by the southern wall of the late Gothic extension against the masonry chamber ('kamenate'), a part of the abandoned wood-and-clay building was excavated. Only a small area measuring 6 × 0.6 m was documented (see Fig. 128 in Chapter 11; Fig. 130, 133). The only structural element excavated was burnt Wooden pile 237 embedded in the floor in the north-south direction, which divided the context into two somewhat different parts (Fig. 134). The entire assemblage was greatly disturbed by recent Backfill 215. In the western part of the building, Trampled layer 236 was placed on the floor, which was covered by Walking level 235 and on top of it by Layer 234 formed by fire. A fragment of the Floor sandwich 231 to 233 rested on it. In the eastern part of the building, separated by the beam, the bedrock gradually became deeper by about 0.35 cm compared to the western part. Several Floor layers 238 to 241 were deposited on the geological bedrock. On top of them was Layer 242 with a series of laminar footings. It is not entirely clear whether these are two buildings or two phases of the same building. Nevertheless, the ceramic material dates the context prior to the middle of the 13th century. To verify the interpretation, a micromorphological sample was taken as in the case of s. u. g. 1. Due to the different levels of the oldest floor in the case of

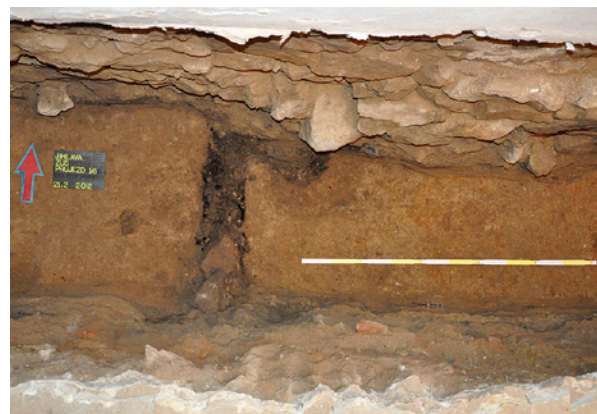
Fig. 134. Jihlava. View into Test pit S14 to the floor with a remnant of a burnt wooden beam of former wood-and-clay Building s. u. g. 2. Photo by Archaia Brno, Inv. No. 23990-2012.

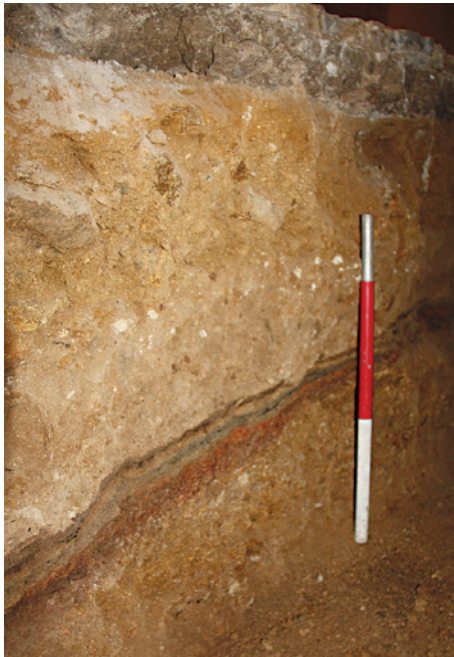
Fig. 136. Jihlava. View into Test pit S10 and Section R1b. Floor strata denoted as s. u. g. 3. Photo by Archaia Brno, Inv. No. 1426-2012.

In the front part of the passageway of the house at 16 Masarykovo Square, in Test pit S10 placed along the north wall of the house from the year 1260, the floor level situated at the geological bedrock, which is probably related to its walking and non-domestic function, was documented (see Fig. 128 in Chapter 11; Fig. 136). The geological bedrock excavated there was strongly burned in several places and Floor and Trampled layers 178 to 179 were formed on it. These layers were covered by Embankment layer 174 raising the floor of the passageway to the current level. A micromorphological sample was also taken from this context. The goal of the sampling was the possibility to interpret the formation processes and to compare this sample with the context in the s. u. g. 1 and s. u. g. 2 structures.

Within this sample, it was possible to divide four macroscopically distinct layers with very different formation processes. The composition and granular microstructure of the uppermost layer found in the thin section indicates that it was created only as a result of the destruction of the feature. It also contains fragments of the original active layer deposited below it (Fig. 137a). The trampled layer itself is only 2 cm thick and is made up of horizontally placed charcoal, remains of plant fragments, eggshells (Fig. 137b yellow arrows), fragments of burnt bones (Fig. 137b blue arrows) and fragments of fish bones (Fig. 137b red arrows). This material can be interpreted as common kitchen waste. Phytoliths are often articulated and laid in a horizontal position and indicate the fact that straw or hay was deposited on the surface on which people moved. The content of charcoal in the trampled layer is variable: in some parts it is up to 50% (Fig. 137b), in other parts it is up to 3% (Fig. 137c). The active trampled layer with a sharp boundary sits on the passive floor layer. This is formed by unsorted clay-like dusty sediment with an admixture of coarse-grained sand (Fig. 137d). Within this sediment, a number of ferric and manganese-rich impregnations and nodules were formed (Fig. 137d, red arrows). This fact indicates changing oxidation-reduction conditions, in this case repeated wetting and drying. At the same

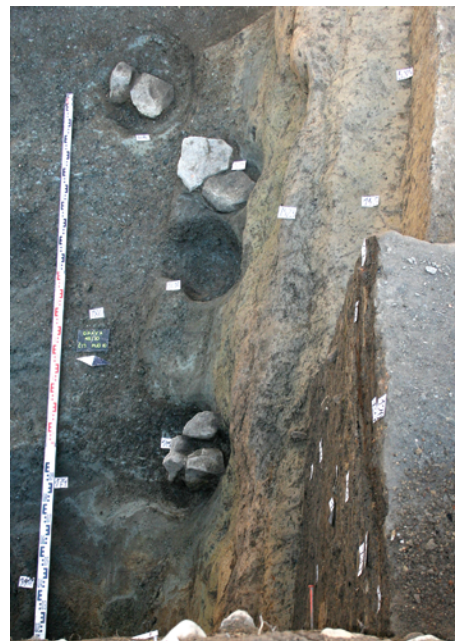
Fig. 141. Opava, former Radniční Street. A row of post holes along the inner edge of the basement of Feature 1523 into which the load-bearing construction reinforced by stones was recessed. Photo by P. Skalická.

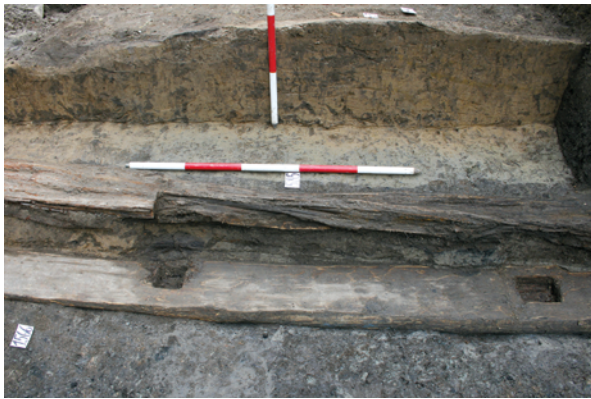
Fig. 142. Opava, former Radniční Street. A detail of the beam ring at the bottom of Feature 585 with the preserved square mortises. Photo by P. Skalická.

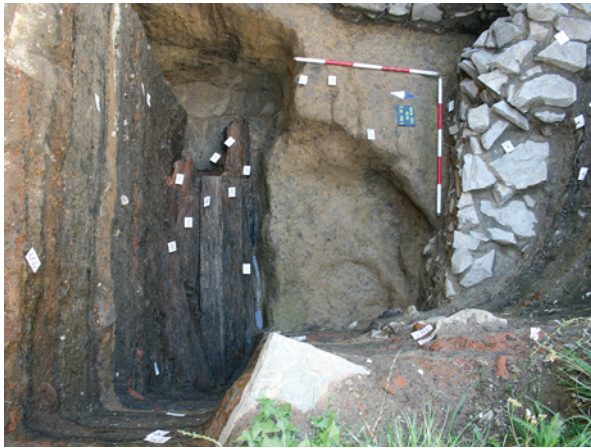
Fig. 143. Opava, former Radniční Street. Collapsed wooden structure in Feature 555. Its wall was far thicker here because of the less stable edge formed by the fill of the earlier feature. Photo by B. Marešová.

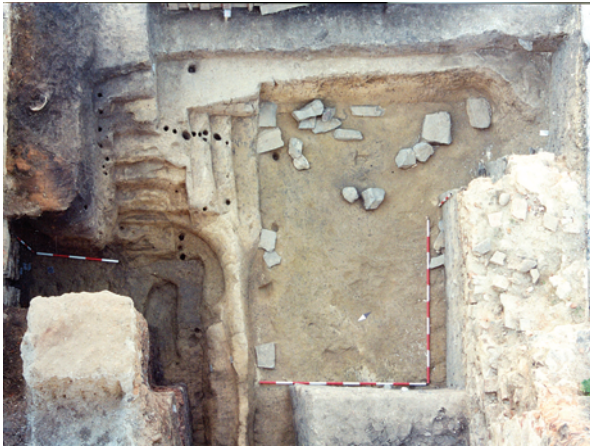
Fig. 145. Opava, Krnovská Street. Superposition of the entrance necks of Feature 502 (15th century) and Feature 532 (16th–17th century). The street front is located to the right of the features. After Kiecoň, Zezula 2005, 36.

The layout of the entrance was discernible for basements in Krnovská and Hradecká streets and near the former Radniční Street (Feature 1523). This always took the form of staircase steps hewn into the loess subsoil. Small stake holes along the sides of the individual steps of the stair detected near Feature 502 in Krnovská Street (Fig. 145) and Feature 1523 in the former Radniční Street are interpreted as traces of wooden reinforcement. The entrance necks were usually situated in the corner area, except for Feature 1523 near the former Radniční Street, where the neck opens into the middle of the longer wall. The position of the entrance with respect to the street line is also variable and is usually situated either perpendicular or parallel to it, depending on the house's position within the plot. As an example, we can name three basements of the later phase of buildings in the former Radniční Street, adjacent to each other and to the street line, where it was impossible due to spatial reasons to design the entrance from anywhere but the rear part of the plot. If a part of the house without a cellar continued above the basement in the direction of the depth of the plot, the entrance neck would be situated in its interior.
