The transformation of burgher houses in medieval Moravia

with respect to
Bohemia and Silesia

Spisy Archeologického ústavu AV ČR Brno 72
Editor-in-chief: Balázs Komoróczy

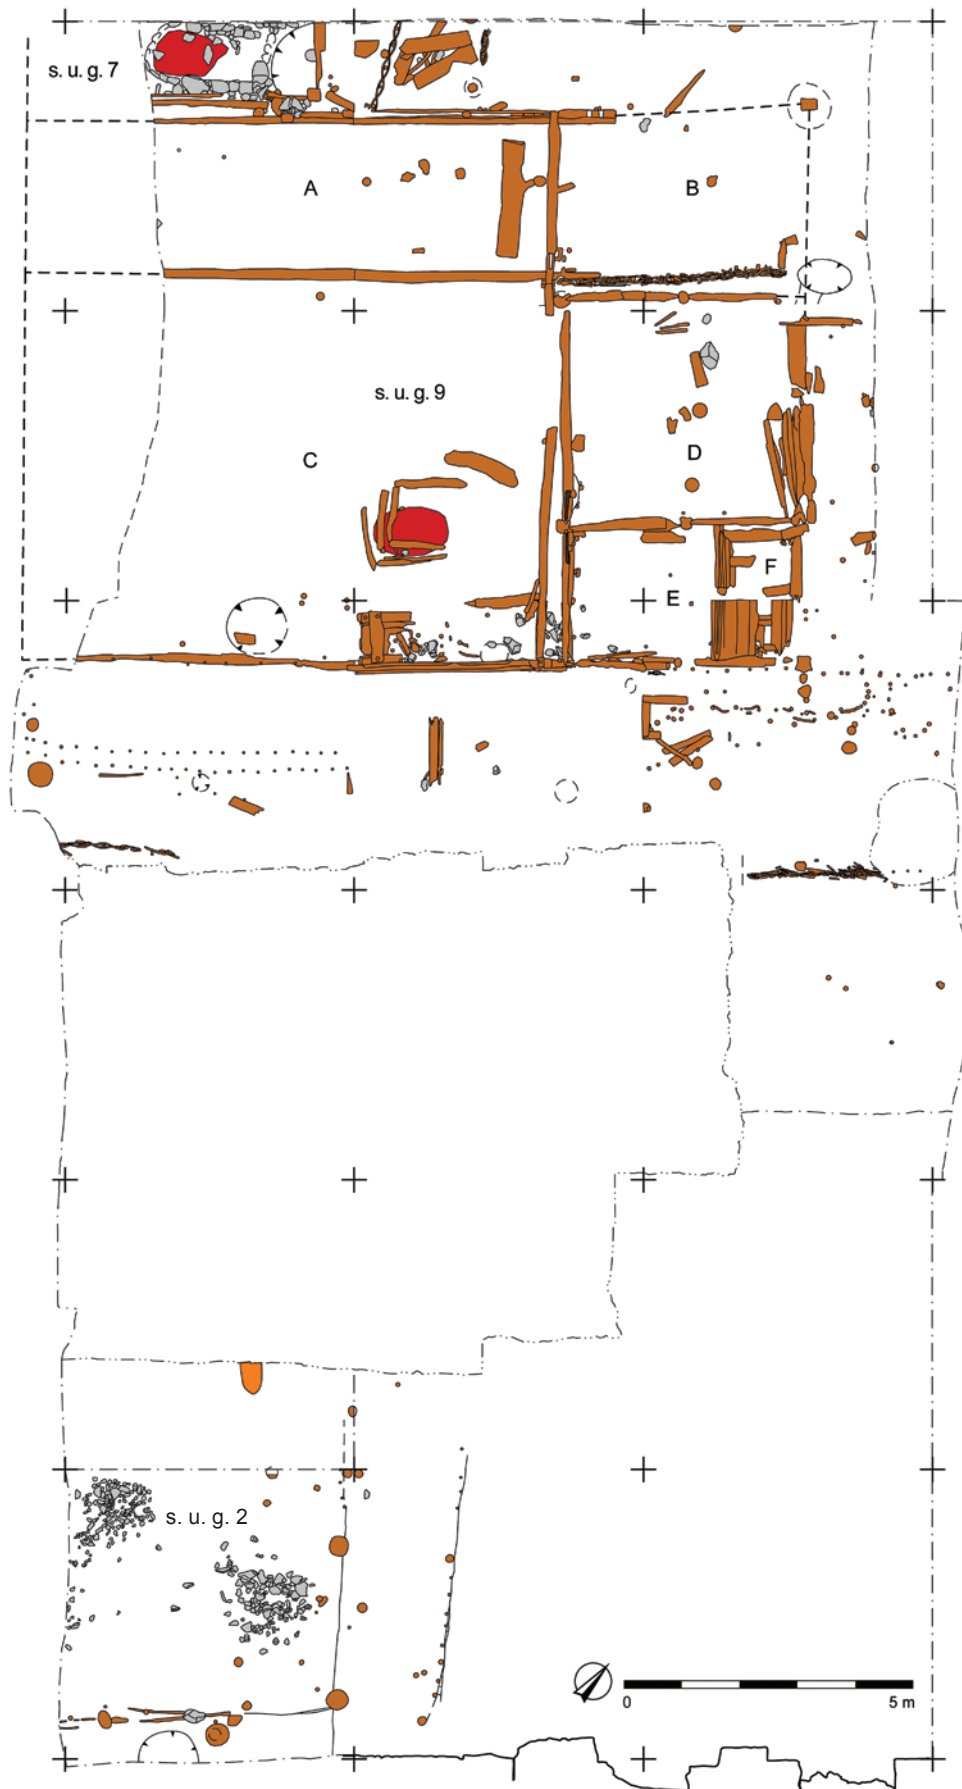
Fig. 154. Uherské Hradiště, Mariánské Square. Second phase. In front, possibly still standing House s. u. g. 2, in back, House s. u. g. 9 and Oven s. u. g. 7. Graphics by B. Veselá, V. Kolařík.

in Brno (Holub et al. 2013, 465). The southeast wall disturbed small ovens (fireplaces?) of the first phase of the house in the south corner of the plot (Fig. 154).

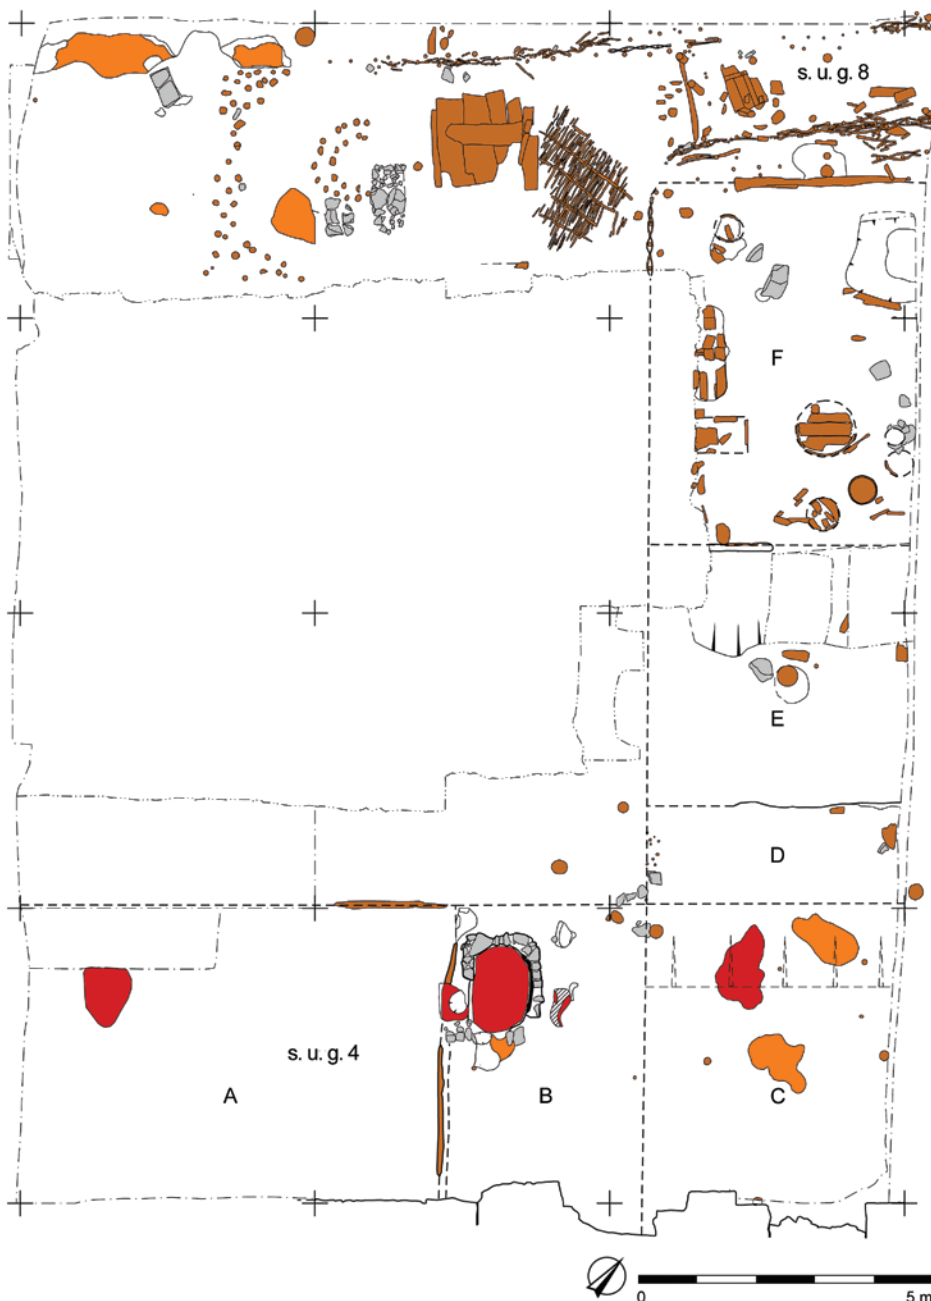
Fig. 156. Uherské Hradiště, Mariánské Square. Third phase, House s. u. g. 4. Graphics by B. Veselá, V. Kolařík.

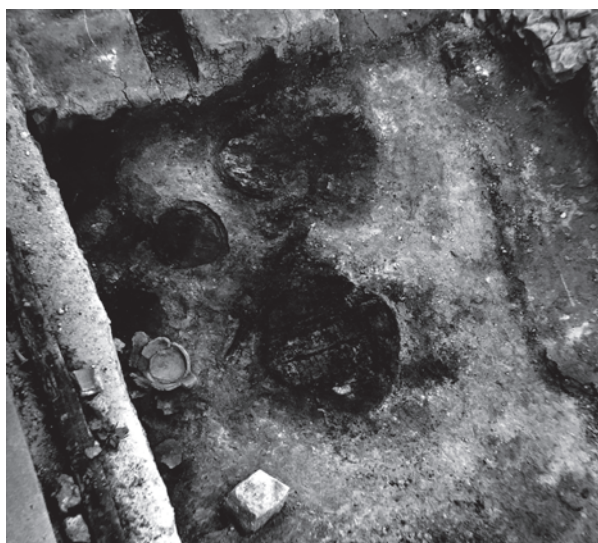
Fig. 157. Uherské Hradiště, Mariánské Square. Store building F of House s. u. g. 4 of third phase with burned bottoms of barrels. Photo by L. Chvalkovský.

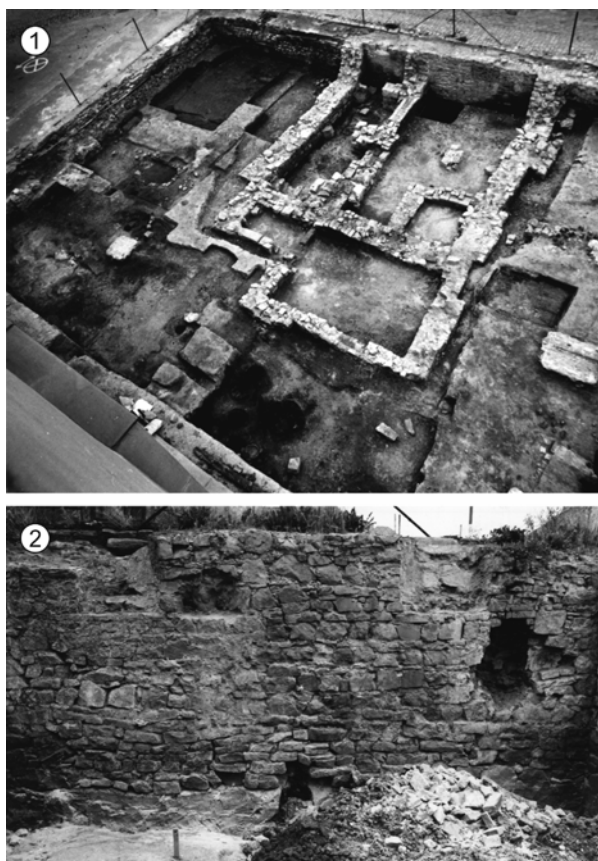
Fig. 159. Uherské Hradiště, Mariánské Square. Fourth phase, House s. u. g. 1. 1 – View of lower part of walls from north; 2 – southwest wall with visible window openings. Photo by L. Chvalkovský.

The stratigraphic position of House s. u. g. 1 is not quite evident from the preserved documentation. Regrettably, parts of the area between the stone house and the front part of the House s. u. g. 4 on the relevant level are lacking in the plan documentation; on the northeast side, earlier archaeological contexts are disturbed by later additions to the house.

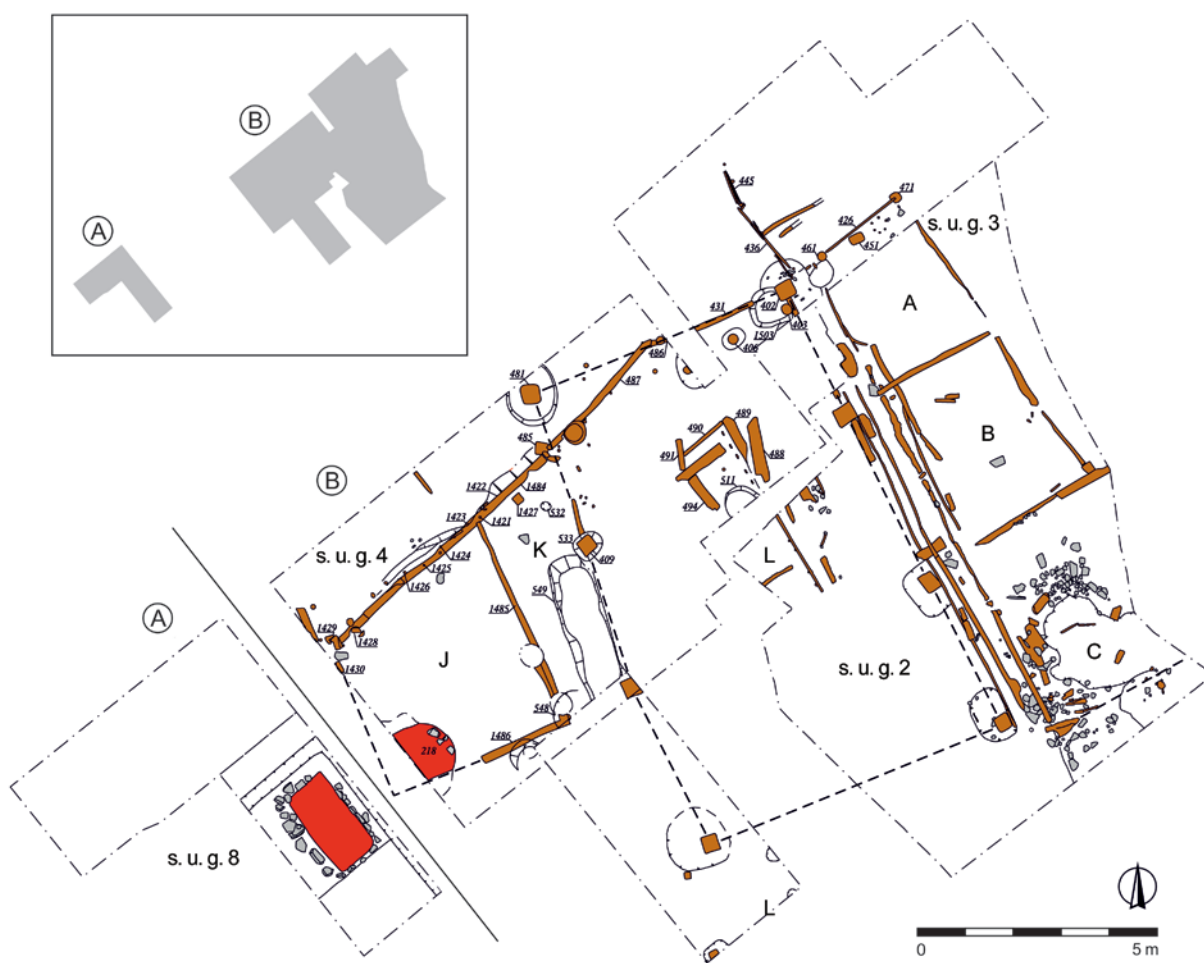
Fig. 169. Uherské Hradiště, Masarykovo Square, Reduta. Second phase, Houses s. u. g. 2 and 4, s. u. g. 3, oven in House s. u. g. 8. Graphics by B. Veselá, V. Kolařík, modified after Kováčik 1997.

by a sill beam of the later (second) period. According to a drawing in the excavation report, it seems that the west wall was shifted all the way to the more distant Post 1429 at that time (Kováčik 1997, Fig. 48). Its new line is indicated by the course of Timber 1430 (see also Fig. 169). Likewise, the south wall was moved when Post 1440 and the corresponding wattle structure ceased to function.

Kováčik and Beroušek included two buildings of a similar orientation in the subsequent **second phase**. In the southwest, it was the large Building s. u. g. 2 (S2). This post-built structure reportedly overlaid the north part of House s. u. g. 1, while the west part ceased to exist (Fig. 169). The front facade of the new building exceeded the previous phase's line by ca 1 m. A sill beam with vertically inserted boards, reportedly later used for the construction of the next phase, is listed in the documentation in the northwest wall. However, no corresponding grooves were registered in the relevant

The **first phase of the house (s. u. g. 3)** was apparently comprised of features denoted as 3 and 5 in the excavation report (Pavelčík 1997; Fig. 169). The more northerly room (Feature 3, in this text A) was delimited by a wattle wall in the southwest and a partition of a similar construction in the southeast. A robust column with a square layout stood ca 3.4 m from the south corner of Room A, near the inner side of the southwest wall. In the southeast, in the extension of the outer wall with an unclear bond, followed a foundation structure, a part of 'Feature 5', i.e. the following Room B. It consisted of two beams originally bound to the column. The elements of the south corner, the only one preserved, were probably jointed by some joinery techniques. As in other cases, the joints did not survive. Beams also comprised the whole eastern front of the building (the southeast corner was disturbed). The northeast front of the sill beam was structured by two posts, one in each room. No traces of a possible partition were detected. The building of a rhomboid (?) shape was at least 12 m long (Room B 5.2 m) and only 2.6 m wide. No hearth or oven were detected. The northwest part was considerably disturbed; the preserved street facade was represented in the first phase by a board set into a pair of posts.

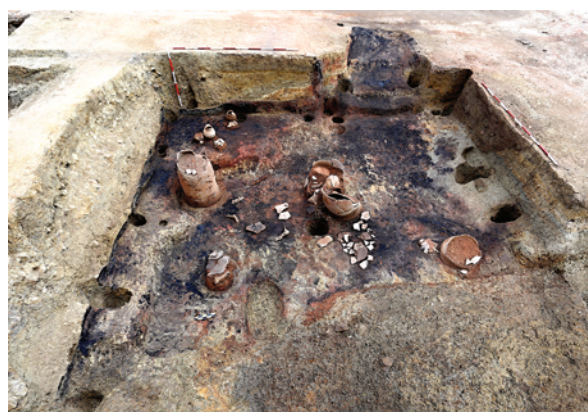
Fig. 173. Uherský Brod, 9 Hradištská Street. View of the basement of the wattle-and-daub building destroyed by fire with the remains of the original equipment (Feature 502). Photo by J. Bartík.

The entire feature had signs of having suffered a heavy fire (Fig. 173). Except for the south elevated level, the entire lower level of the basement was covered with a layer of charred wood. This permits an interpretation that the wooden ceiling, which also forms the floor horizon of the ground floor, collapsed into the basement during the fire. Remnants of the wooden lining of the walls (Fig. 173) and some of the posts (especially around the staircase; Fig. 175) are preserved in the form of compact charcoals in several places. On the basis of an anthracological analysis, it was possible to identify the tree species used. While the supporting columns and planks that lined the basement were made almost exclusively of oak, other woods – beech, fir, linden, elm and hornbeam – were used for the basement ceiling and other wood furnishings from it and the ground floor from which they fell. Among the burnt structural elements, several charred worked pieces of wood (willow, linden) were discovered on the basement floor, which could represent the remains of wooden tools or containers/ crates used for storing supplies.

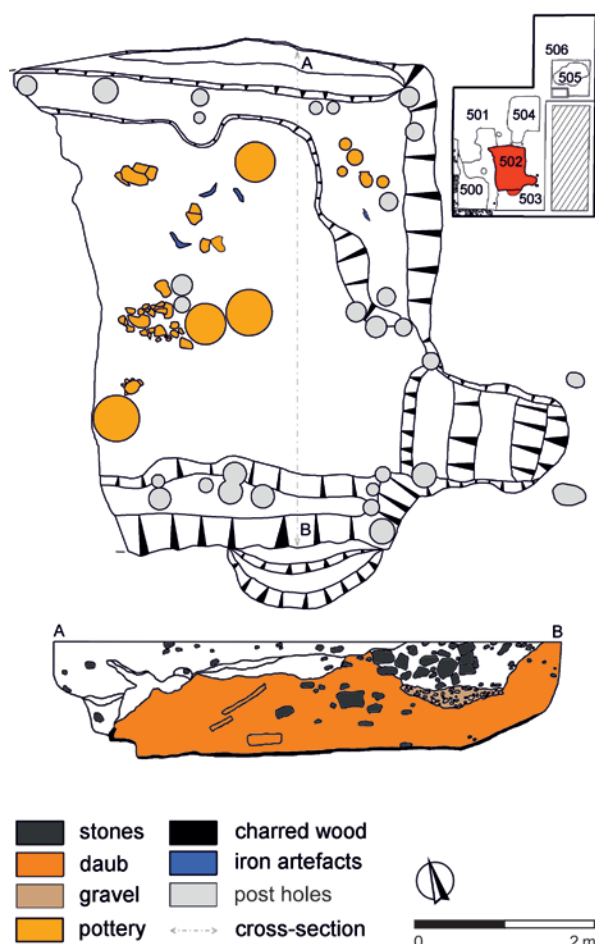
Fig. 172. Uherský Brod, 9 Hradištská Street. Plan view and cross-section of Feature 502. Graphics by J. Bartík, T. Chrástek.

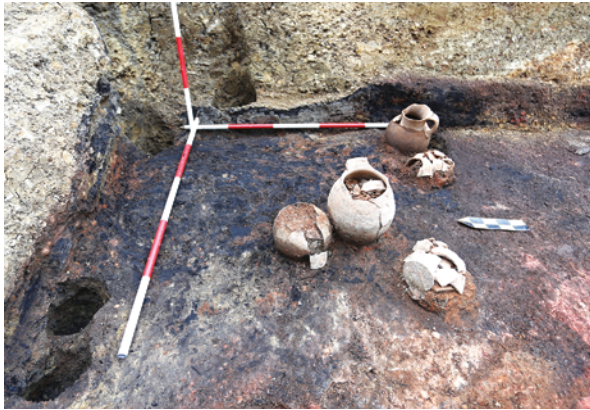
Fig. 174. Uherský Brod, 9 Hradištská Street. View of the raised step in the NE part of the basement with a concentration of pottery vessels and an iron knife. Photo by J. Bartík.

smaller post hole. On the east side, the raised step was significantly widened up to 1 m. In this expanded area, an *in situ* accumulation of five vessels with the remains of fillings inside and a larger iron knife were found (Fig. 174). Typologically, it consisted of one large and two smaller ovoid pots with a frilled rim and two larger jars with one strap handle and a spout on the opposite side. A raised step was also located along the south edge of the feature, but here it was not as regular and the transition to the floor horizon was rather gradual. The width of the upper surface without the slope was 20–40 cm, even with it from 45–70 cm.

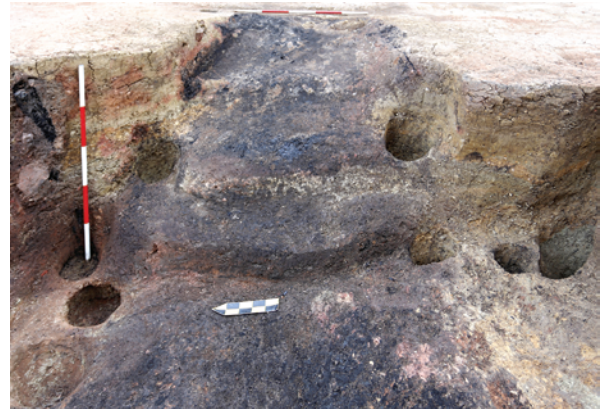
Fig. 175. Uherský Brod, 9 Hradištská Street. View of the east entrance to the basement with the staircase carved into the bedrock and the remains of a charred column. Photo by J. Bartík.

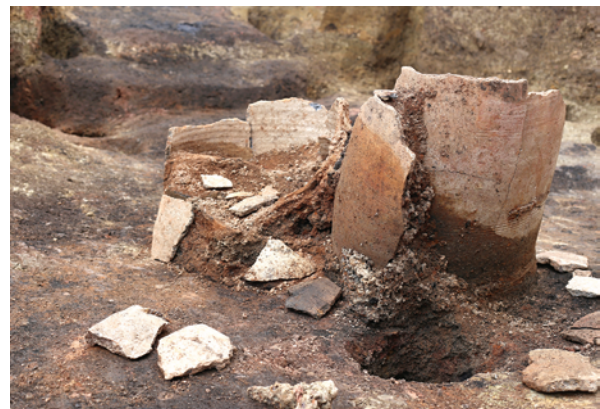
Fig. 176. Uherský Brod, 9 Hradištská Street. View of the damaged ceramic storage vessels standing upside down on the bottom of the basement. Photo by J. Bartík.

Important finds include the preserved remains of the original furnishings of the basement discovered on its floor (made of non-perishable materials, as well as objects made of wood, fabric and other organic materials). These are primarily four large storage vessels, all of which were turned upside down (Fig. 172, 173), indicating that they were probably empty at the time of the fire. Two of the vessels were preserved intact, the other two in fragments due to the disruption of later Feature 501 (Fig. 176). In terms of their spatial distribution, one vessel was located at the north edge of the pit, in a niche formed in the raised step described above, two lay close together in the middle of the basement and the last one was found at the southwest edge. A smaller jug with a handle and a precisely polished surface stood directly on the floor next to the fourth storage vessel. Also noteworthy are several iron construction fittings lying on the floor just a few centimetres apart in the centre of the feature after apparently falling here from the ground floor during the fire. A large number of samples for the wet sieving of sediment were collected from the entire area of the floor. Thanks to the application of this method, it was possible to obtain small burnt grains and other types of plant macroremains, which after their determination (the analysis has not yet been completed) will provide more information about stored food and subsistence habits. The internal structure of the basement is composed of 28 post holes (Fig. 172). These are concentrated around the perimeter of the feature, in two cases next to each other in the centre of the feature and also near the entrance staircase. Several post holes have signs of having been joined

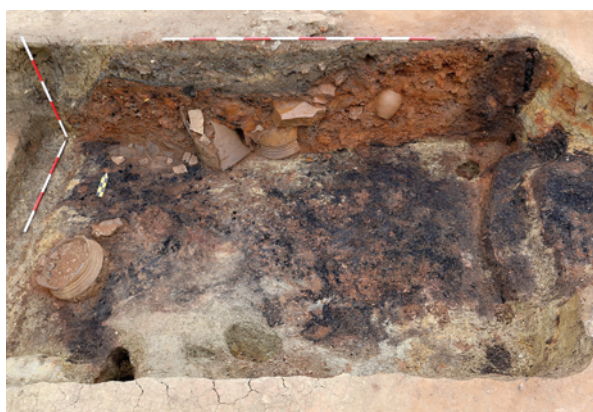
Fig. 177. Uherský Brod, 9 Hradištská Street. View of the fill of Feature 502 with a thick layer of daub, burnt wood and vessels that were part of the furnishings of the basement and which fell into it from the ground floor. Photo by J. Bartík.

and backfilled. A total of 13 contexts were macroscopically determined in the fill of Feature 502. The fill's stratigraphy can be divided into two parts. The lower part with a significantly higher content can be linked to the destruction of the above-ground part of the building, which collapsed into the basement, including the material located on the ground floor. With the exception of the aforementioned layer of burnt wood at the floor level, the lower part of the fill consisted mostly of a thick layer of daub rubble with recognisable pieces of burnt wood in places (the high magnetic susceptibility of the layer peaked due to burning between $1.19\text{--}8.25 \times 10^{-3}$ SI units). The layer is not flat and instead appears to form an oblique cone from the east and southeast towards the northwest (Fig. 177). Another seven complete pottery forms that had fallen from the above-ground part of the building as the ceiling and walls collapsed were found at various heights in the described layer of daub rubble. Typologically, these were five bell-shaped lids, one large ovoid pot with a body decorated with grooves and a frilled rim decorated with a simple wavy line, and one small beaker with a wide neck and also furnished with a frilled rim. An iron key heavily damaged by heat was also found with them.

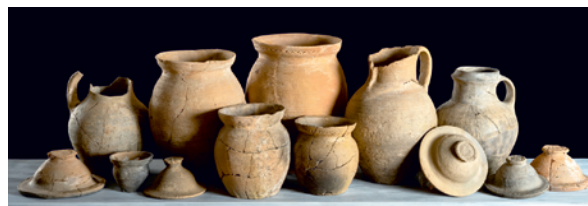
Fig. 178. Uherský Brod, 9 Hradištská Street. A set of ceramic vessels discovered on the floor and in the rubble cone of the fill of Feature 502. Photo by T. Heřmánek.

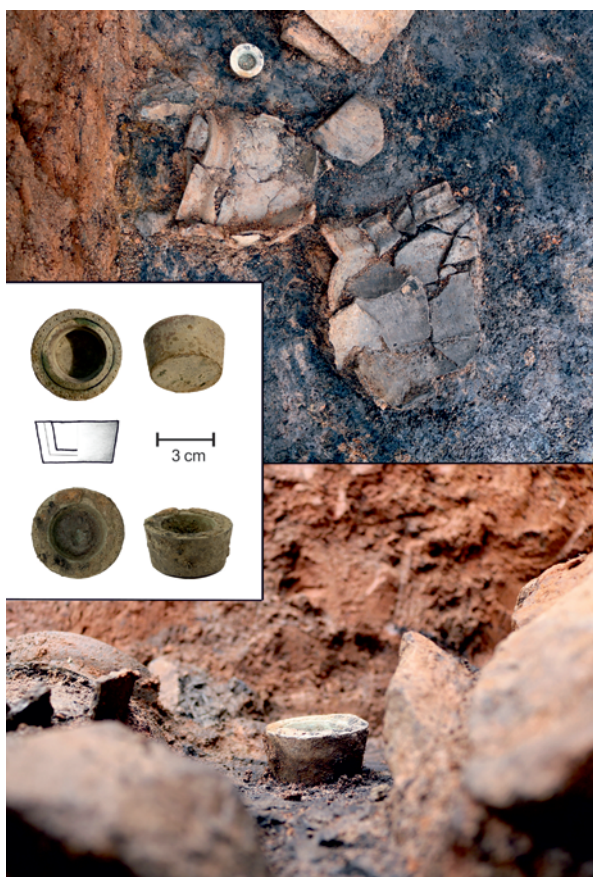
Fig. 180. Uherský Brod, Masarykovo Square. Vessels on the floor of the basement and a detail of two cup-shaped weights before and after cleaning. Photo by M. Přibyllová, drawing by M. Maršíčková.

While no artefacts from the period of the functioning of the feature were found in the space of Tunnelled cellar 06, the context in Basement 08 was very different. In the southern half of the investigated part of the feature, three ceramic pots and two bowl-shaped merchant weights of non-ferrous metal lay *in situ* on the floor (Fig. 180). A large amount of a charred mixture of wheat and rye combined with

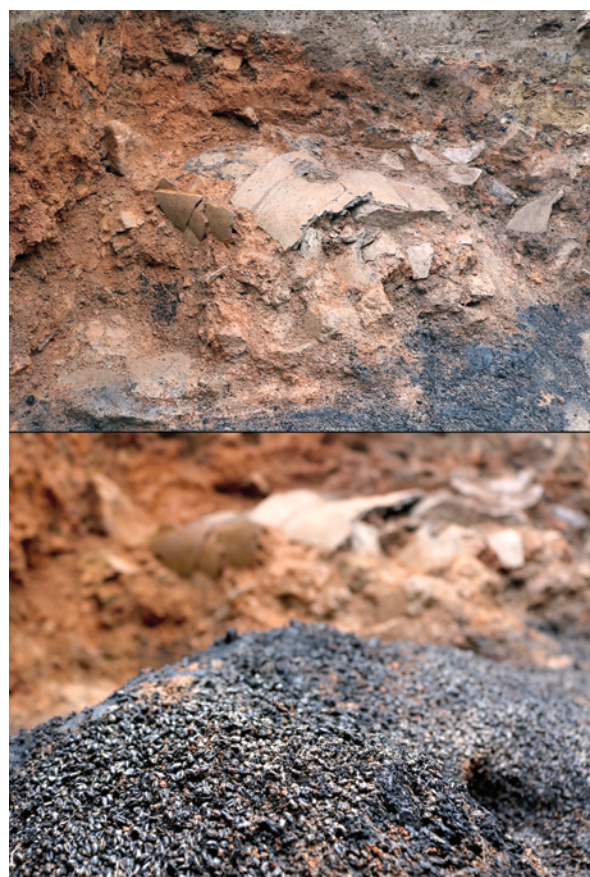
Fig. 181. Uherský Brod, Masarykovo Square. Fill of Basement 08. Above: fragments of storage vessels that fell into the basement from the above-ground levels of the building. Below: detail of charred mixture of cereals found on the basement floor. Photo by Archaia Brno.

linden charcoals was also uncovered. We can assume that a container made of linden wood holding a mixture of cereals intended for the preparation of flour was stored on the basement floor (Fig. 181). This was the only basement on the plot that was not completely searched after its demise for the purpose of salvaging items that survived the fire.

The entire context was covered by a mass of daub that was created during the fire and subsequent collapse of the house into the bowels of the basement (Fig. 182, 183). This rubble also contained a concentration of fragments of storage vessels which likely collapsed into the basement along with the debris (Fig. 181, 182). It is puzzling why the occupants of the house would deliberately clutter the living space in the residential part of the building with large storage vessels while using the basement to store supplies in smaller containers. It is possible that there was simply no room in the storage area of the house for the storage vessels. The basement may have been

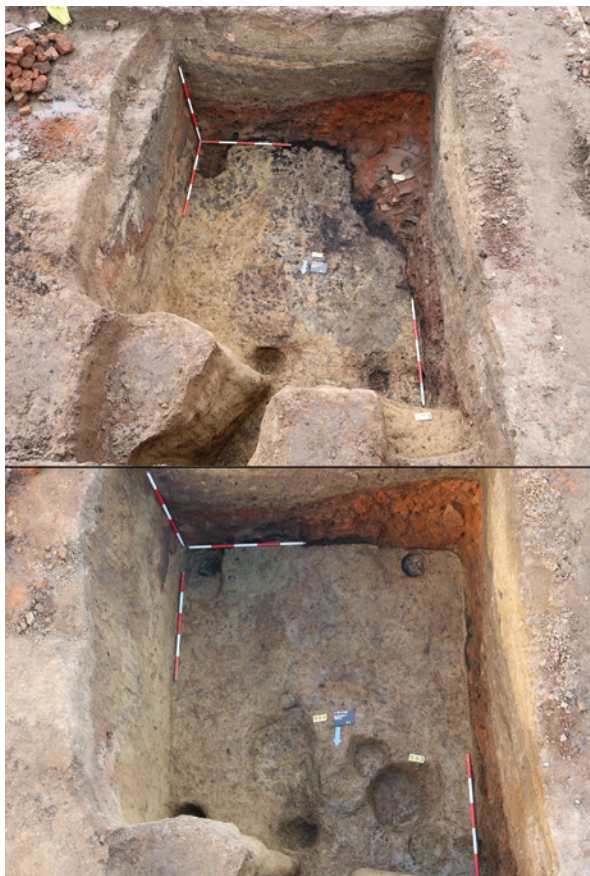
Fig. 182. Uherský Brod, Masarykovo Square. Documentation phase of the NE part of Basement 08. Above: part of the fill of the basement *in situ*. Below: Basement and post holes after excavation of fill. The entrance neck to Cellar 06 is visible on the north wall. Photo by Archaia Brno.

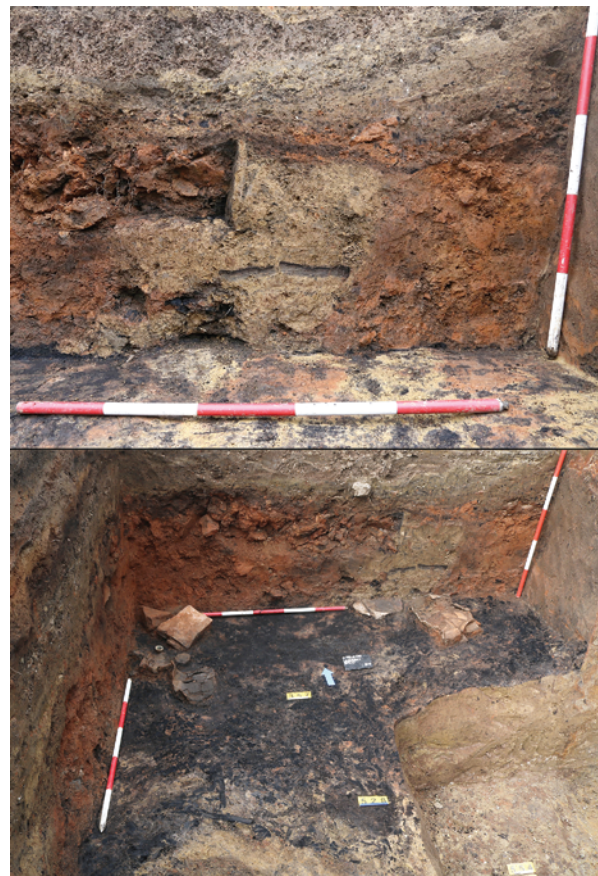
Fig. 183. Uherský Brod, Masarykovo Square. Southeast part of Basement 08. Above: detail of hypothetical heating device captured in the profile of the test pit. Below: artefacts buried by the house rubble on the floor of the basement. Photo by Archaia Brno.

A daub block, which included a distinctive burnt crust, also collapsed into the basement during the fire (Fig. 183). With a great deal of circumspection, this context could be interpreted as a relic of a heating device from the upper floor that fell into the basement during the fire. This is also suggested by the presence of stone in close proximity to the hypothetical heating device. A similar context was uncovered in Basement 01 in Mozartova Street in Brno (Holub et al. 2005a, 65, 86).

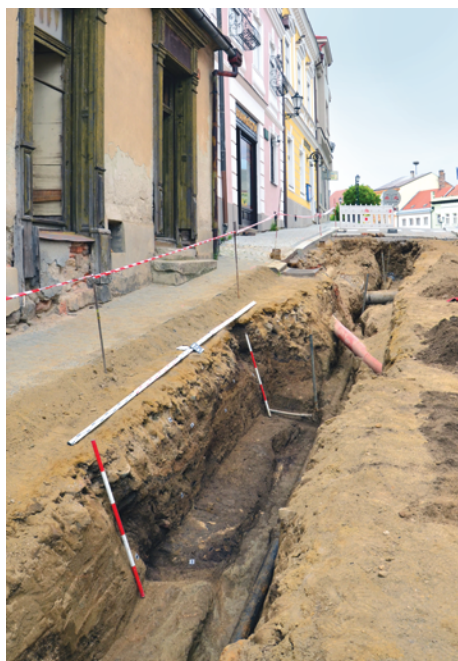
Fig. 188. View from the south of the section of the wood-and-clay Basement s. u. 500. Photo by Archaia Brno.

On the western side of the excavations for the water pipe construction, a sedimentary section through the basement was documented. The basement belongs to the wood-and-clay house, is 5.6 m long and a depth of 0.7–1.0 m into the weathered gneiss bedrock was documented (Fig. 188, 189). The walls of the basement were vertical and straight, with a sharp transition to the bottom. Two post holes with a diameter of 0.26 and 0.4 m were uncovered at the bottom near the walls. The entrance neck was not captured in the documented part of the excavation.

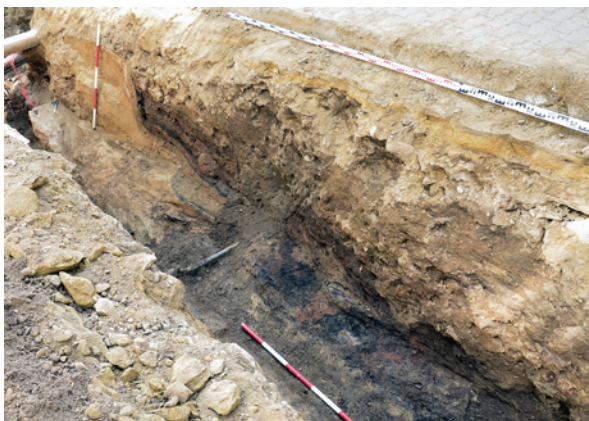
Fig. 190. View from the north-east of the section of the former wood-and-clay Basement s. u. 503. Photo by Archaia Brno.

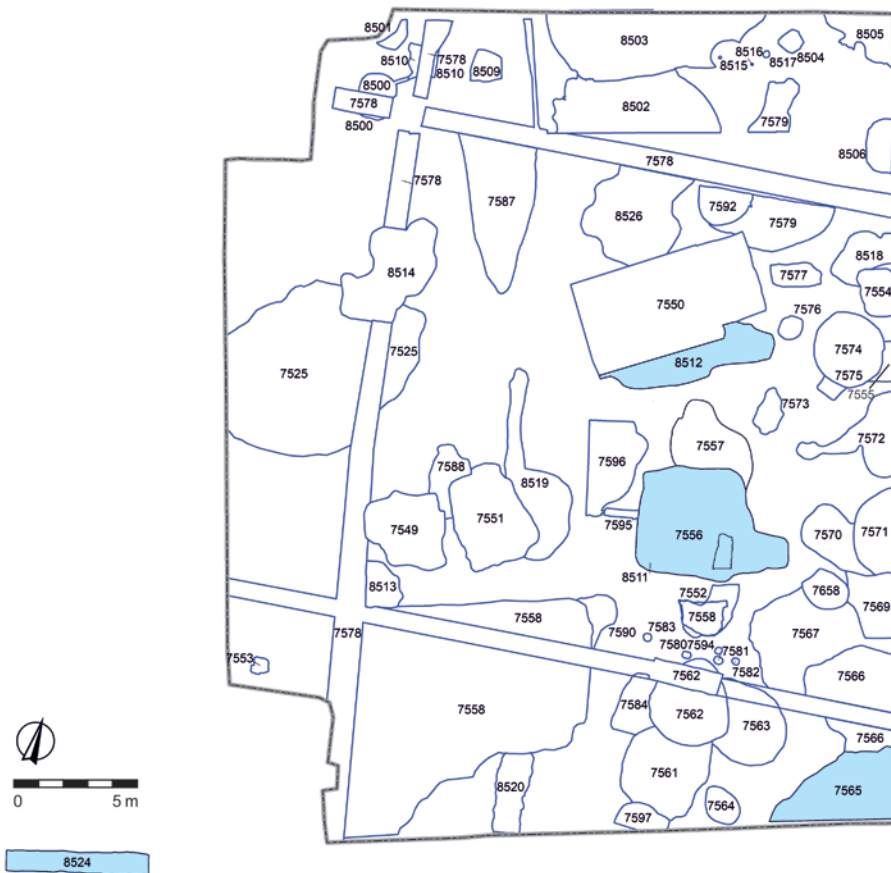
Fig. 196. Jihlava – Staré Hory. Excavation area in 2018 with the marked location of Basements 7556, 7565, 8512 and Feature 8524. Digitised by M. Košťálová.

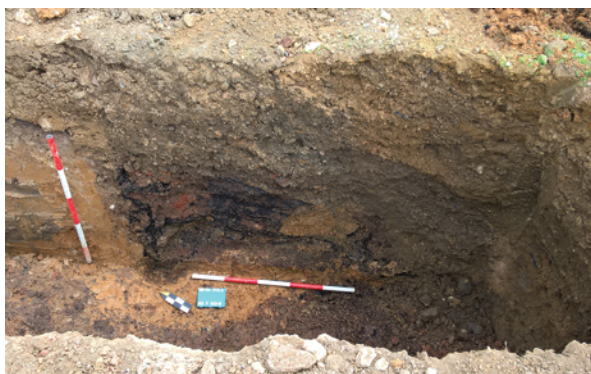
Fig. 202. Jihlava – Staré Hory. Photo of the NE corner of Basement 7565 with a post hole, the remains of a charred column and charred horizontal planks on the eastern wall. Photo by Archaia Brno.

Basement 8523 (7565 respectively) was documented during the digging of the foundation passes for the kindergarten building in the southeast corner of the area and, unfortunately, was only documented as sections. It most likely originally represented a rectangular building with perpendicular, straight walls and a sharply connected flat bottom, recessed 1.3 m below the level of the subsoil. For the most part, it intervened outside the excavation area. Unlike the other three residential buildings in question, it was destroyed by fire. As a result, remains of charred wood were preserved in the northeast corner of the basement, on the walls and the floor. In the northeast corner was the remains of the column with planks inserted with a thickness of approximately 2 cm and a width of at least 20 cm (Fig. 202, 203). The above-ground part of the building, or part of it, was built from rounded logs and

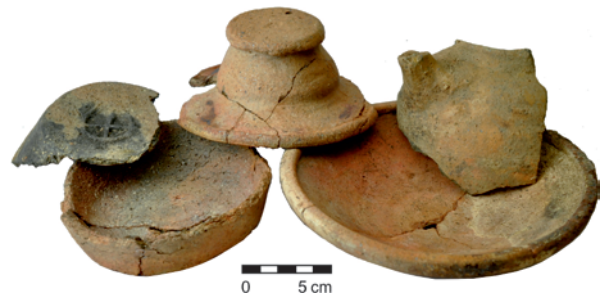
Fig. 204. Jihlava – Staré Hory. Ceramic vessels excavated from the fill of Basement 7565 damaged by fire. Photo by J. Těsnohlídek.

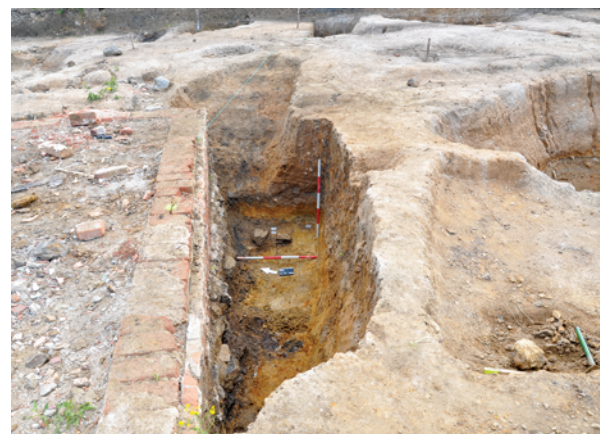
Fig. 206. Jihlava – Staré Hory. Photo of the entrance neck and SE corner of Basement 8512. Photo by Archaia Brno.

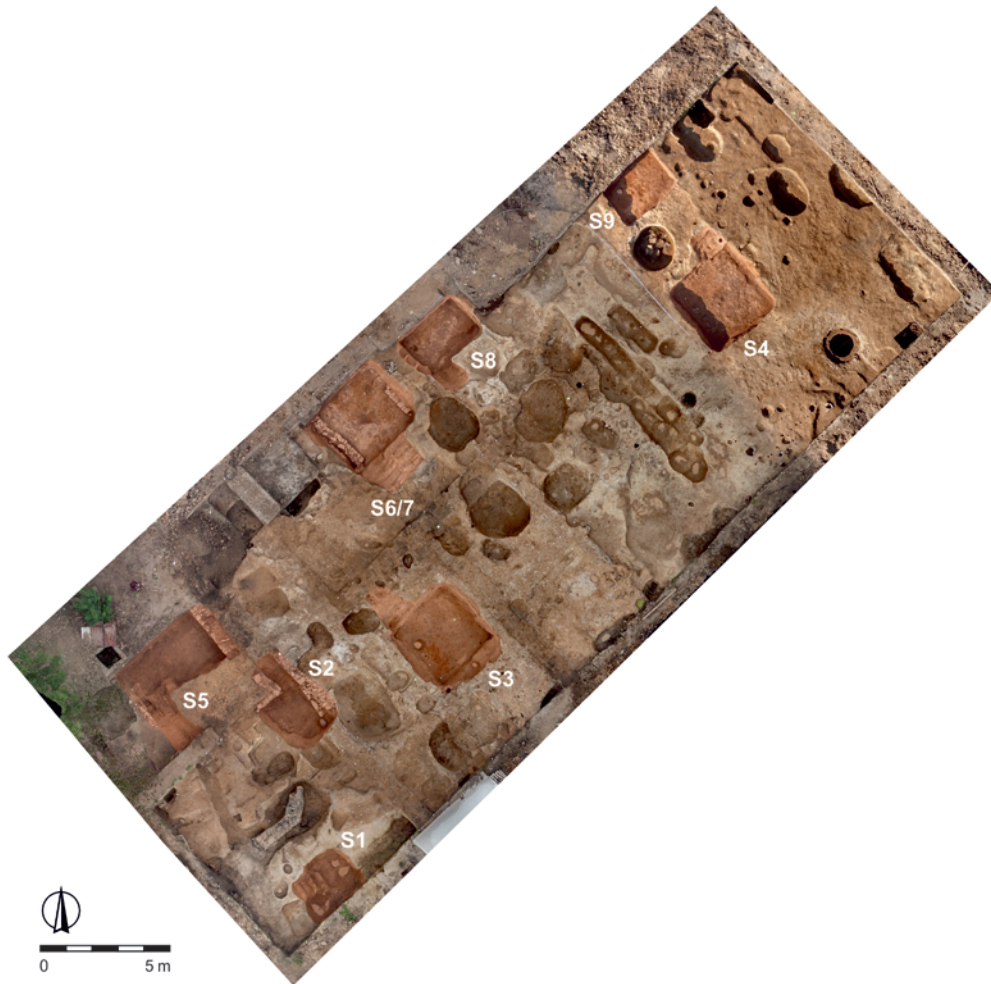
Fig. 211. Osoblaha. Aerial view of the excavated area with marked former basements of wood-and-clay buildings. Author V. Dudková.

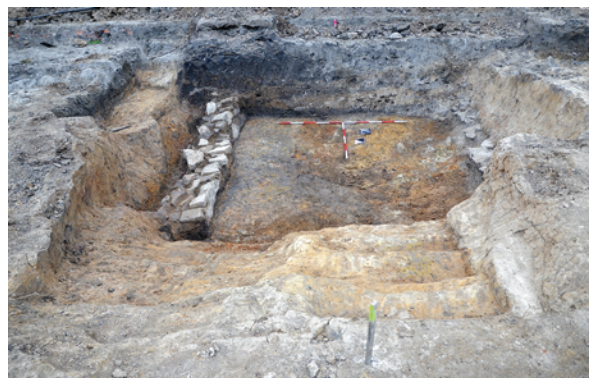
Fig. 215. Osoblaha. Basement S6. View from the southeast. Photo by Archaia Olomouc.

for structural stability, based on the original floor of the former medieval basement. The context of Basements S6/S7 was of extraordinary interest and two phases of the entrance neck were documented for them (Fig. 215). A daub accumulation containing stone pebbles was detected in the eastern part within the destruction stratigraphy of the later of these two basements (15th century). Its character could indicate the destruction of a heating device situated on the ground floor of the house. The destruction horizons of the two basements, dated to the first half of the 14th century and the 15th century respectively, also indicate that they might represent a relatively long continuity of one house with traces of partial

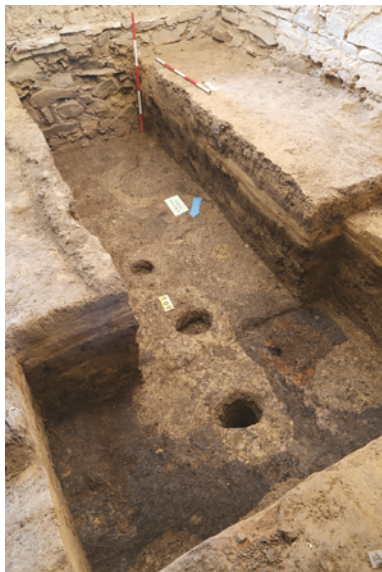
Fig. 218. Kučerov. A trench in the sitting room with the cleaned-up post-built structure of the medieval building phase of the house overlaid by the later floors of the sitting room. A view from the north towards the village square. Photo Archive of Archaia Brno, Inv. No. 07667-2016.

Rescue archaeological excavation in House No. 43 in Kučerov (Vyškov District) (Fig. 218, 219) was caused by the complete reconstruction of the building, which began in 2016. The house is a part of a terraced development in the southwestern part of the village square. The existing longitudinally oriented homestead with a hook-shaped layout constructed of unfired bricks dates from the first third of the 19th century (approximately). The house underwent a major reconstruction in the third quarter of the 19th century, and the last major alterations to its residential area took place in the early 1920s. It is designed as a double-wing with an adjacent passage to the yard.

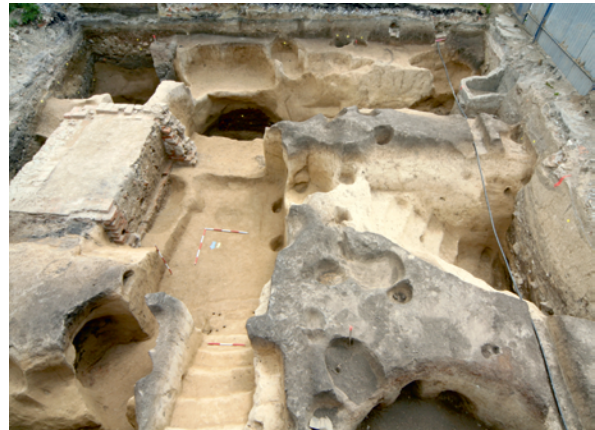
Fig. 222. Brno, Královo Pole. An overall view from the north of the context featuring the uncovered small cellar s. u. 607. Photo Archive of Archaia Brno, Inv. No. 06586-2009.

Rescue archaeological excavation was caused by the preparation of ‘Residence Mojžírovo náměstí’. The area of study is located in the cadastral area of Královo Pole (currently part of Brno), at the eastern front of Mojžírovo Square (Fig. 222–224). Mojžírovo Square still preserves in its floor plan the medieval village square of the important Brno suburban village, Královo Pole. The documented settlement of Královo Pole begins in the first half of the 13th century. In the front part of the plots, the remains of columnar above-ground buildings, fragments of their clay floors, excavations of wood-and-clay basements and a large number of loess-carved underground lots were documented. It can be found in this settlement phase at the street front and in the background of the

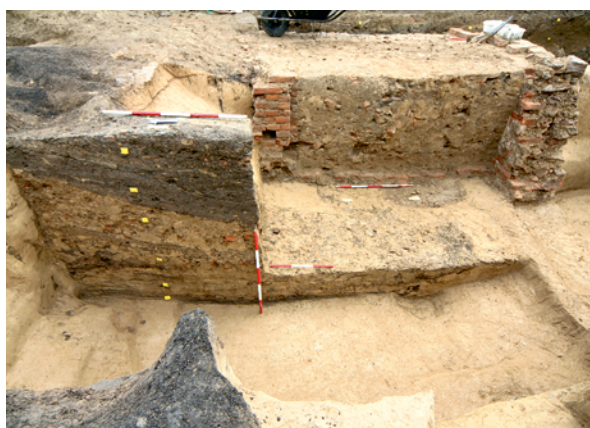
Fig. 224. Brno, Královo Pole. A view of the west of the infilled cellar and the floor layers. Photo Archive of Archaia Brno, Inv. No. 06619-2009.

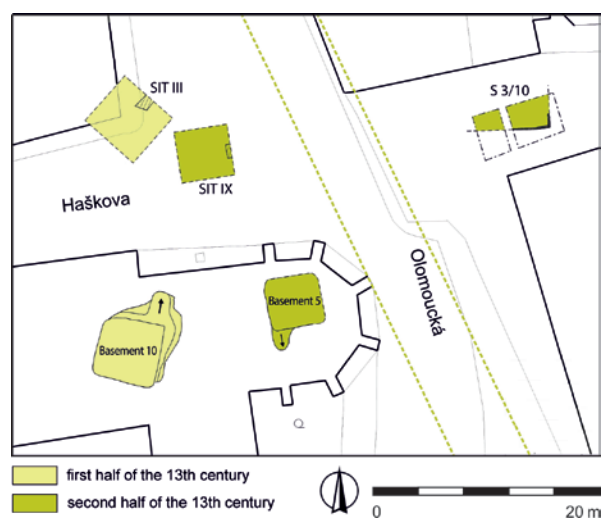
Fig. 246. Uničov, crossroads of Haškova and Olomoucká streets with Church of Exaltation of Holy Cross. The plan shows documented parts of basements of former wood-and-clay houses. After Šlězár 2013, 63, modified by M. Peška.
