ITAM ARCCHIP
INSTITUTE OF THEORETICAL
AND APPLIED MECHANICS

1 / 2021

ST. WENCESLAS ROTUNDA IN THE LESSER TOWN OF PRAGUE – SURVEY OF INTERIOR PLASTER WITH WALL PAINTING

PENDULUM VIBRATION ABSORBER ON THE BREWERY LOOKOUT TOWER

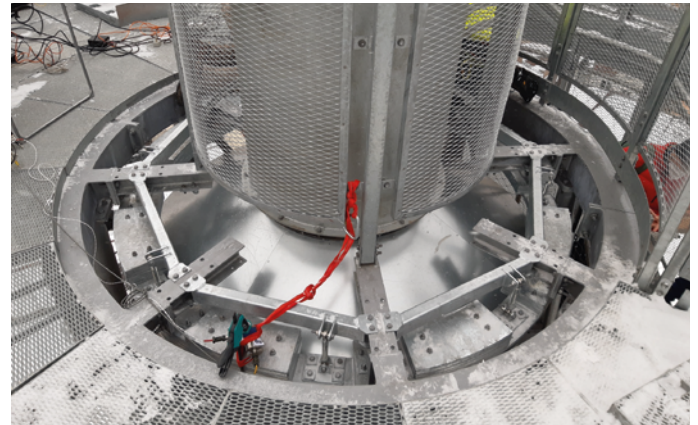
Fig. 2. Ring absorber with sensors already deployed. Photo: S. Hračov

Before opening the tower to the public, it was necessary to test the dynamic characteristics of the entire structure, and, if needed, to design and install a vibration absorber. This was important because high-rise buildings, such as the Bernard lookout tower, can be subject to unwanted vibrations due to wind or the movement of persons which affect the well-being of the people on the structure – standing on a swinging platform 30 m above the ground is not at all pleasant. During the dynamic tests carried out by researchers from ITAM CAS led by Shota Urushadze, it was found that the observation platform of the structure without a vibration absorber shows an above-limit response caused by the movement of persons on the tower structure. It was therefore necessary to install a suitable vibration absorber, which would effectively reduce the level of vibration of the structure. The pendulum absorber designed for the Bernard lookout tower took the form of a large metal ring placed around the chimney, weighs a ton and is attached to the supporting structure of the viewing platform by eight hinges (Fig. 2). With the hinges the absorber can move in all directions. The kinetic energy of the vibrating structure of the lookout tower is transferred to the pendulum absorber, which then also oscillates. It acts "against" the movement of the lookout tower structure, thus dampening its vibrations. Part of the kinetic energy is also absorbed by friction in the hinges.

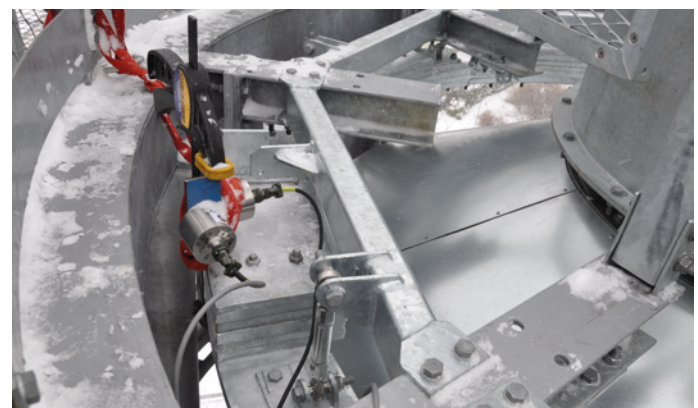
Fig. 3. A detail of the hinges and one pair of sensors. Photo: B. Přečová

The vibration absorber was designed by the Head of the Department of Dynamics and Aerodynamics, Stanislav Hračov, and was installed by Excon, a.s. The dynamic characteristics tests, this time with the absorber, were again conducted by our colleagues from ITAM CAS. First they verified the functionality of the suspension elements in the Central Laboratory at ITAM. A total of six sensors (accelerometers) were then installed on the viewing platform which measured the acceleration of the structure during various types of excitation (wind, a person walking on the stairs, moving people on the platform, vandalism – intentional oscillation of the platform, etc.) with an active as well as a blocked absorber. An important part of the tests was to verify the functionality and behaviour of the absorbers during all of these activities. The accelerometers were placed in pairs at different places on the platform, and measured the response in two mutually perpendicular horizontal directions.

The tests showed a slight decrease in the lowest resonant frequency compared to before installing the absorber. At the same time, the installation of the absorber in the construction of the lookout tower led to a significant reduction in the vibration level. When the tower oscillated due to human force, the resistance of the active absorber could be seen to prevent the attainment of the resonant state and its prolonged maintenance. The analysis of the response showed that the effective values in forced oscillations decreased by seven times, and the maximum values by six. It was thus possible to state that, with an active vibration absorber, the lookout tower is suitable for safe operation. The pendulum absorber can be viewed during a visit after climbing all 191 steps.
